## **The Bhutan-Swiss Archaeology Project**

### **The first excavation campaign at Drapham Dzong in Central Bhutan Administrative report**

## **Bhutan-Swiss Archaeology Project Drapham Dzong 08** **Results of the first excavation campaign (autumn 2008)**

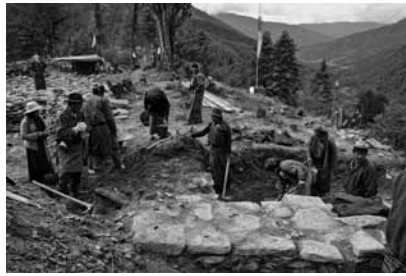
7

**Fig. 7** The primary wall in zone K

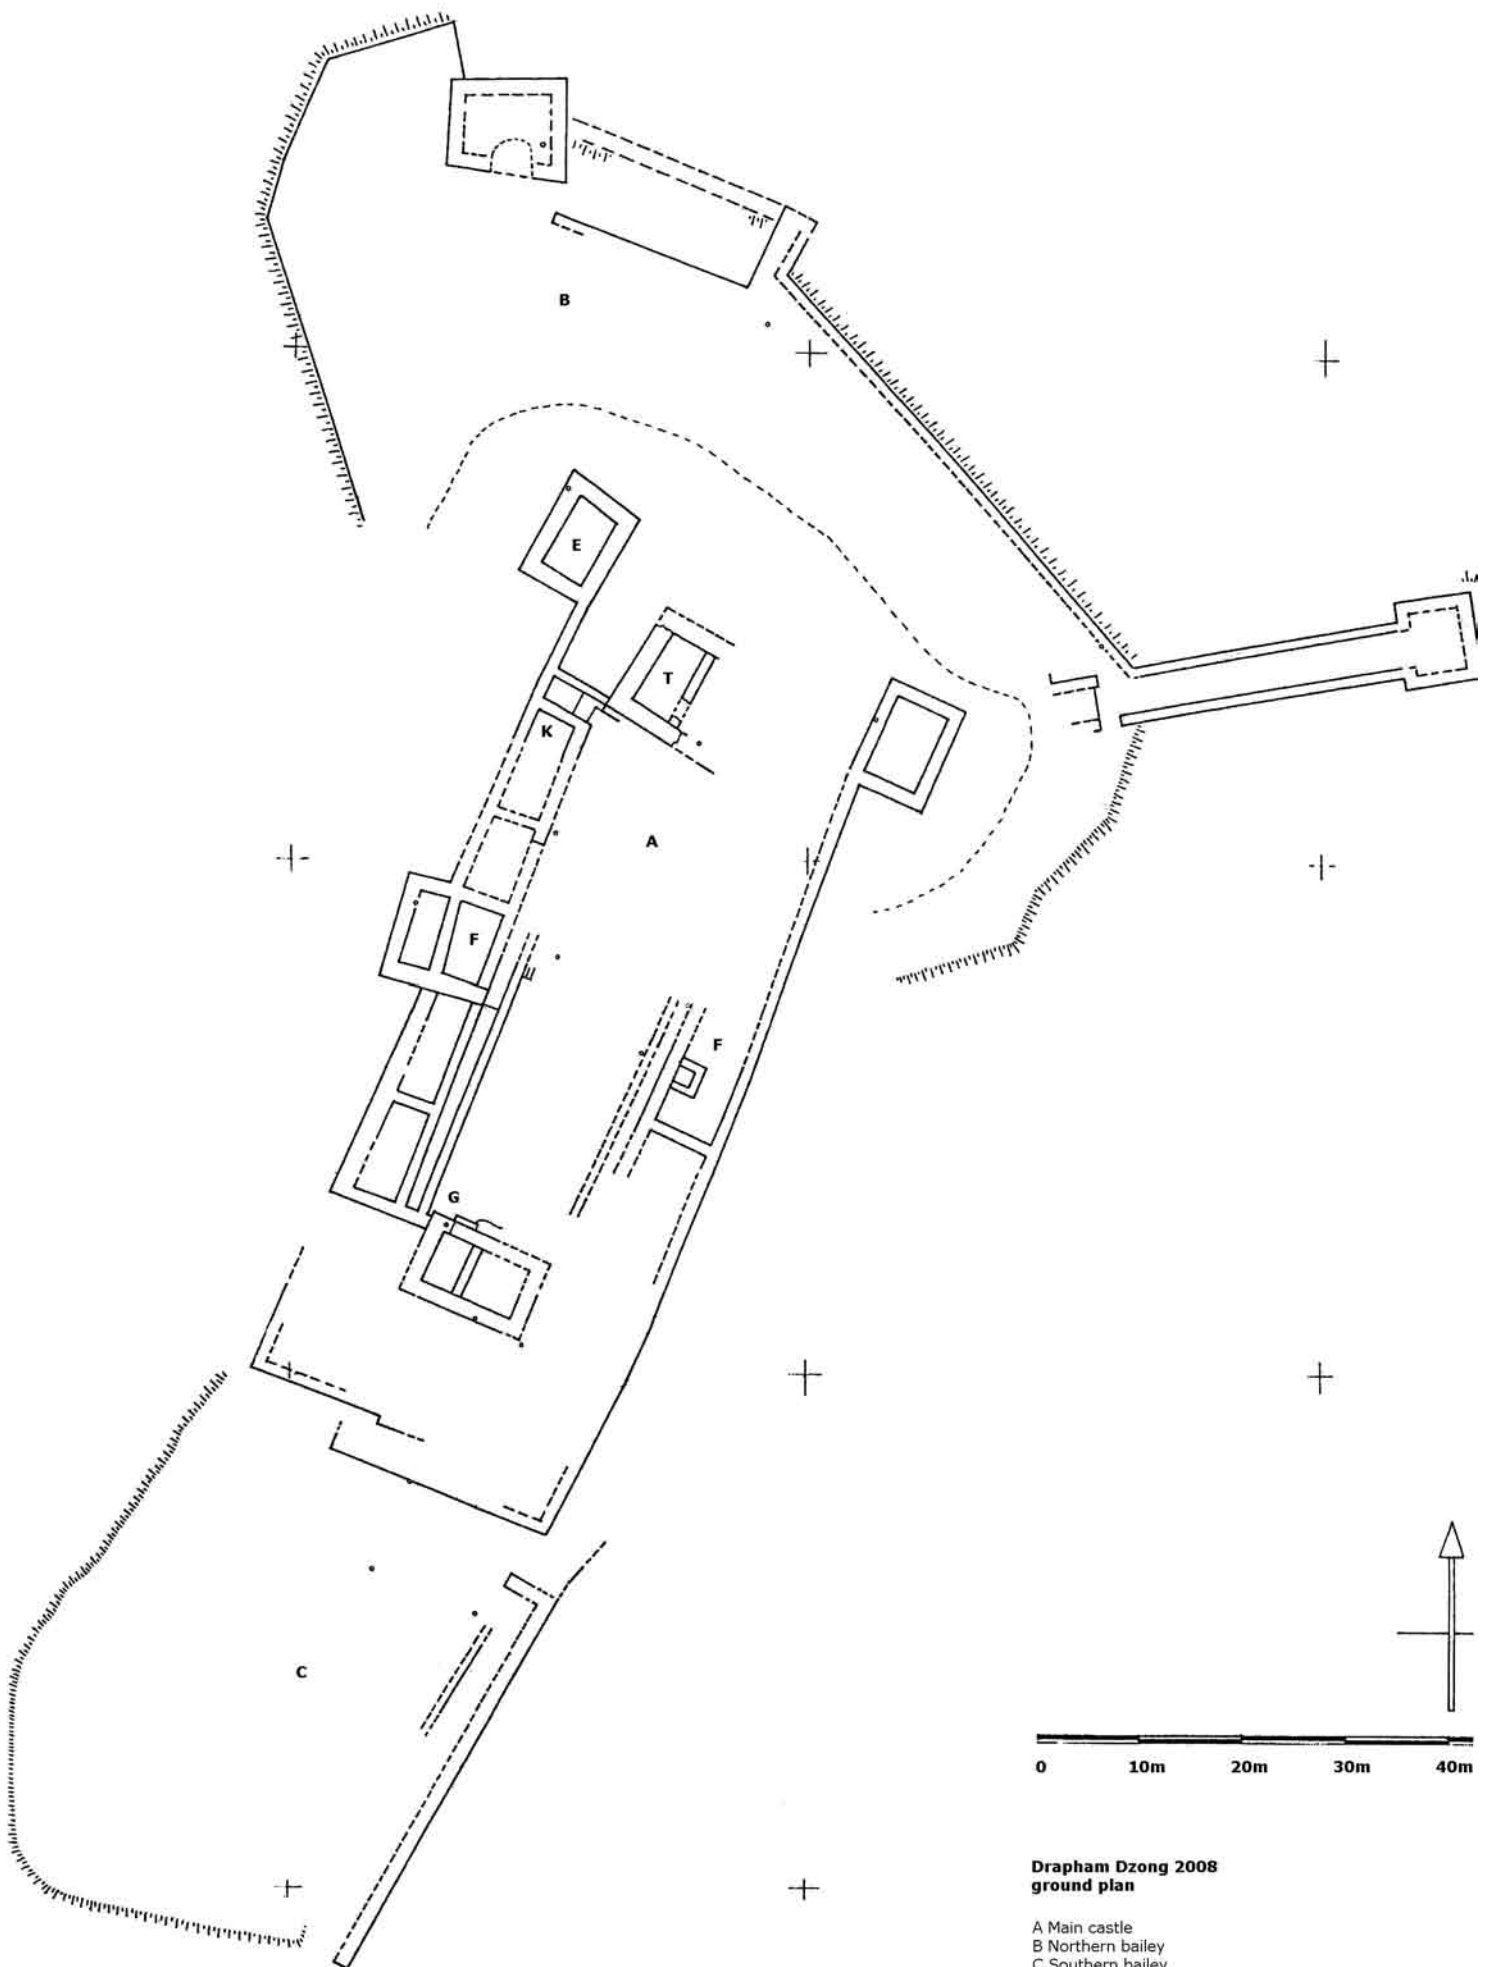
**Drapham Dzong 2008  
ground plan**

A Main castle  
B Northern bailey  
C Southern bailey

The different sections were named as zones using capital letters (E, F, G, L, K, T). Inside each zone the complexes of the layers were numbered (e.g. E3); the rooms were also numbered by means of lower case letters (e.g. Fb). Finally, the walls were numbered as well (e.g. W1ff).

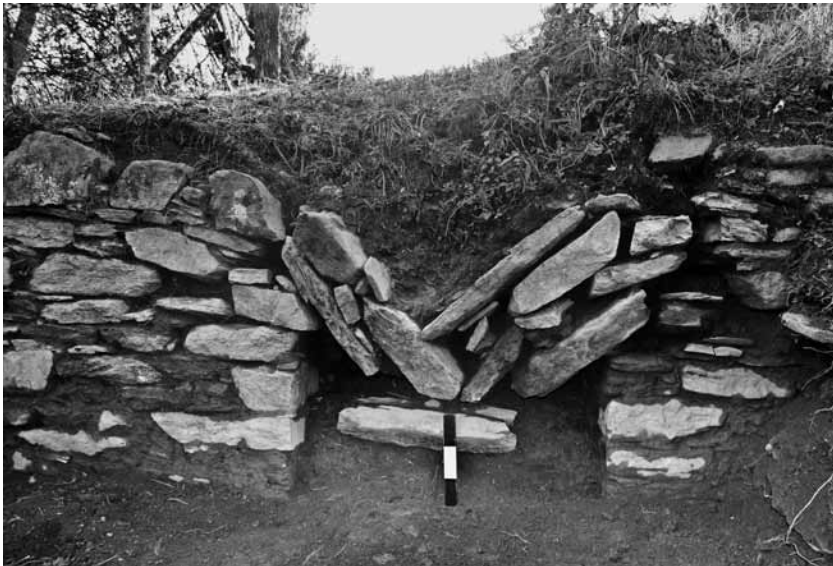
Fig. 15 Window case with collapsed lintel in zone E

(approx. 10 by 10 cm and approx. 30 cm deep) were used to brace the scaffolding. The remains of wood we found in these recesses are suitable for radiocarbon dating but unfortunately not large enough for a dendrochronological analyse. Some parts of the wall, mainly in the corners and on the wall copings, show clear traces of damage to the brickwork, intentionally inflicted by human activities.

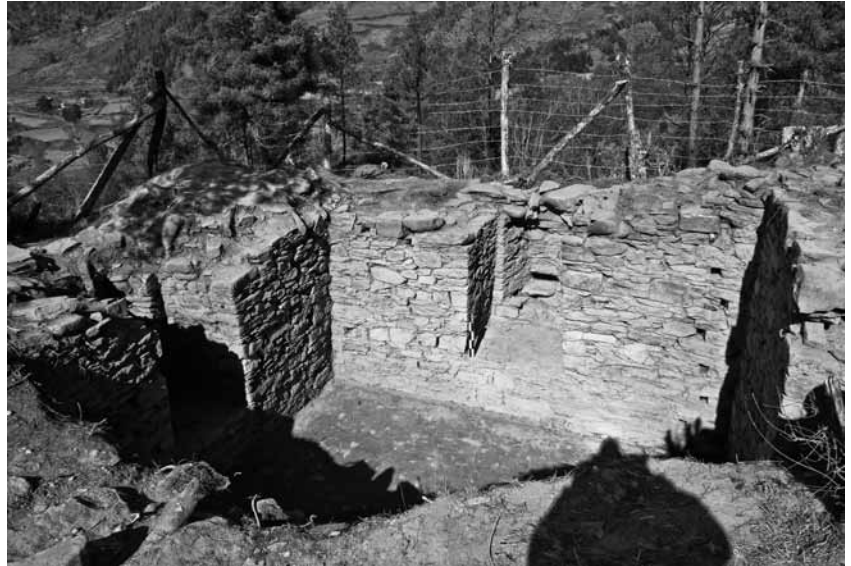
Fig. 16 NW view to the northern tower in the corner, zone E

The northern half of the tower was excavated (room Ea). In the soil we found an unexpectedly large amount of brickwork. Five arrow loops appeared with small recesses behind them. We were able to completely uncover three of them. The interior of the tower was mainly filled with secondary debris. A burnt layer with remainders of beams must originate from a demolished upper floor. For the moment being, it was impossible to approach the ground level.

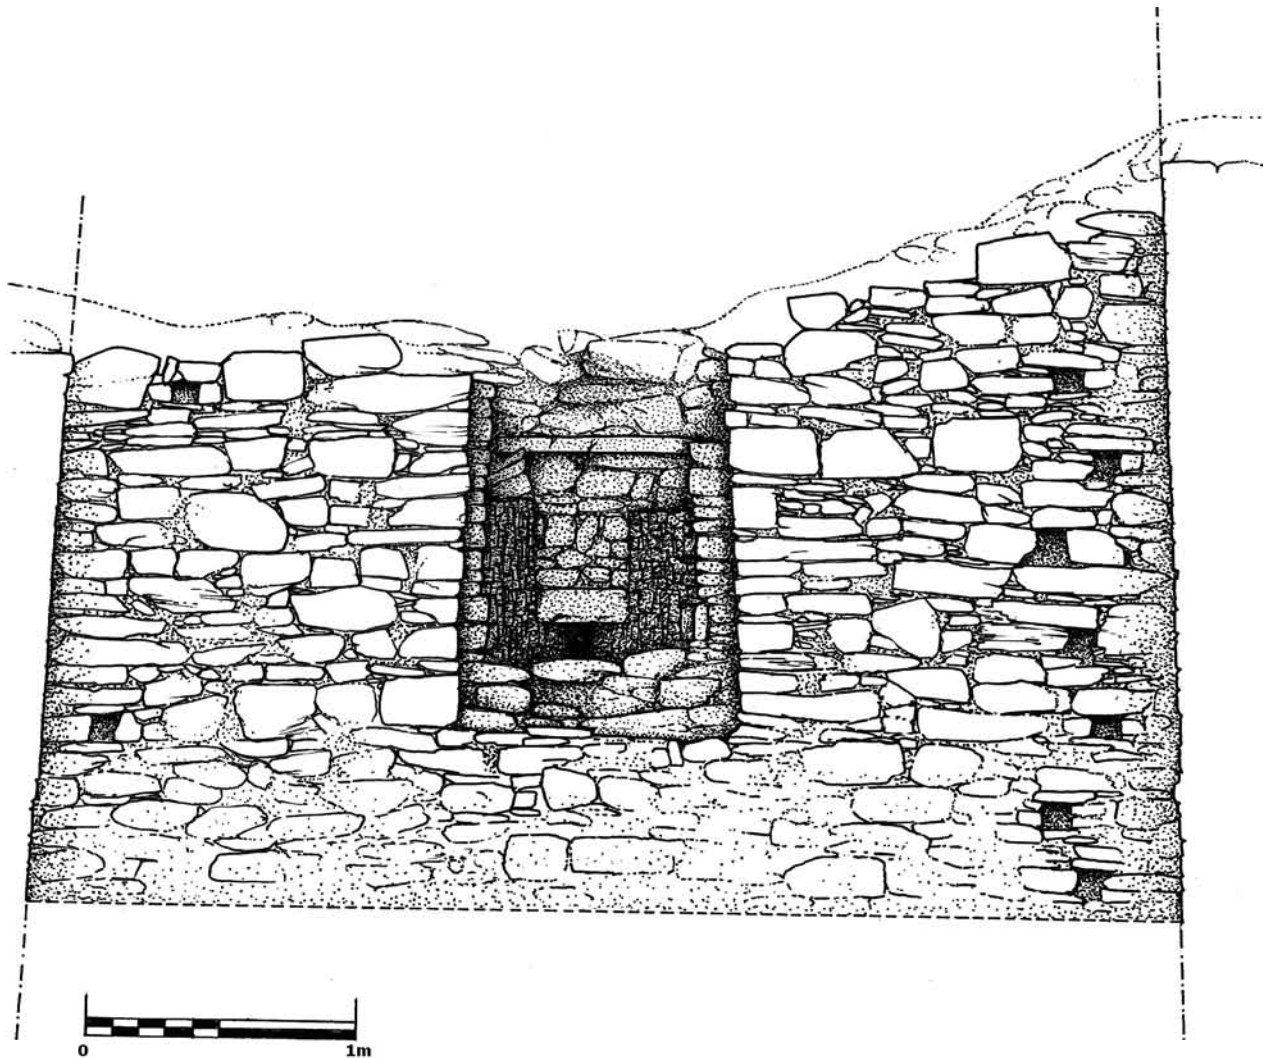
Fig. 17 North-western tower in the corner zone E, wall W1a with arrow loop

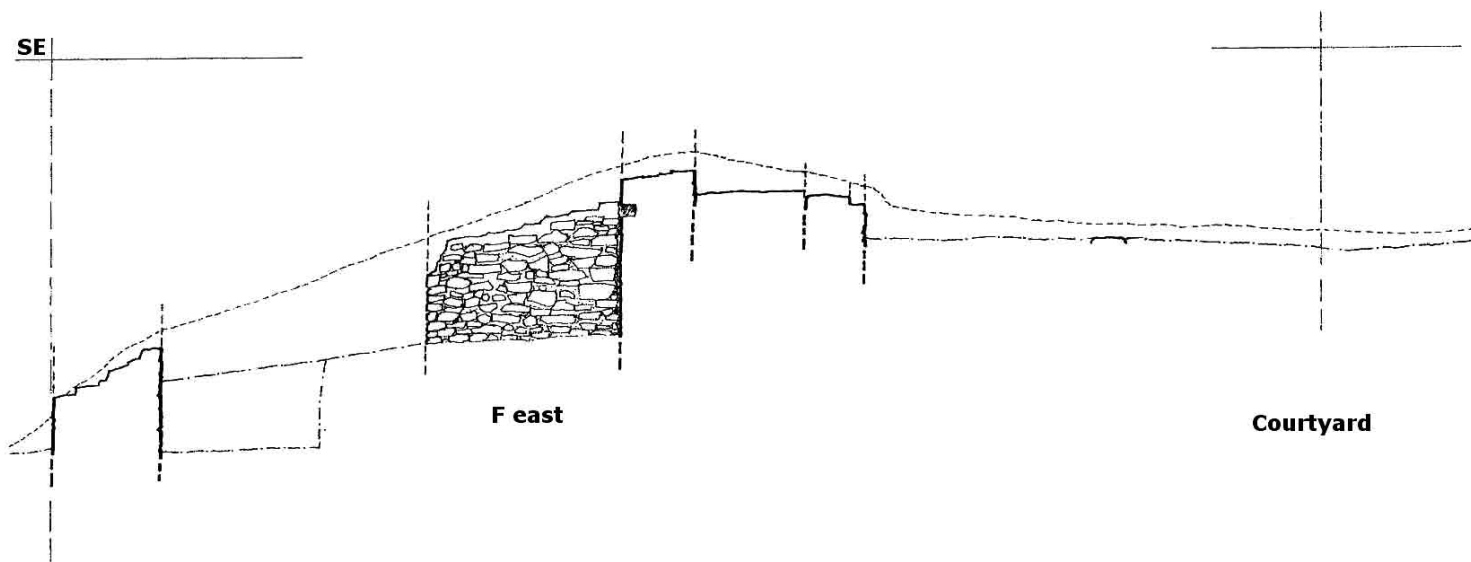
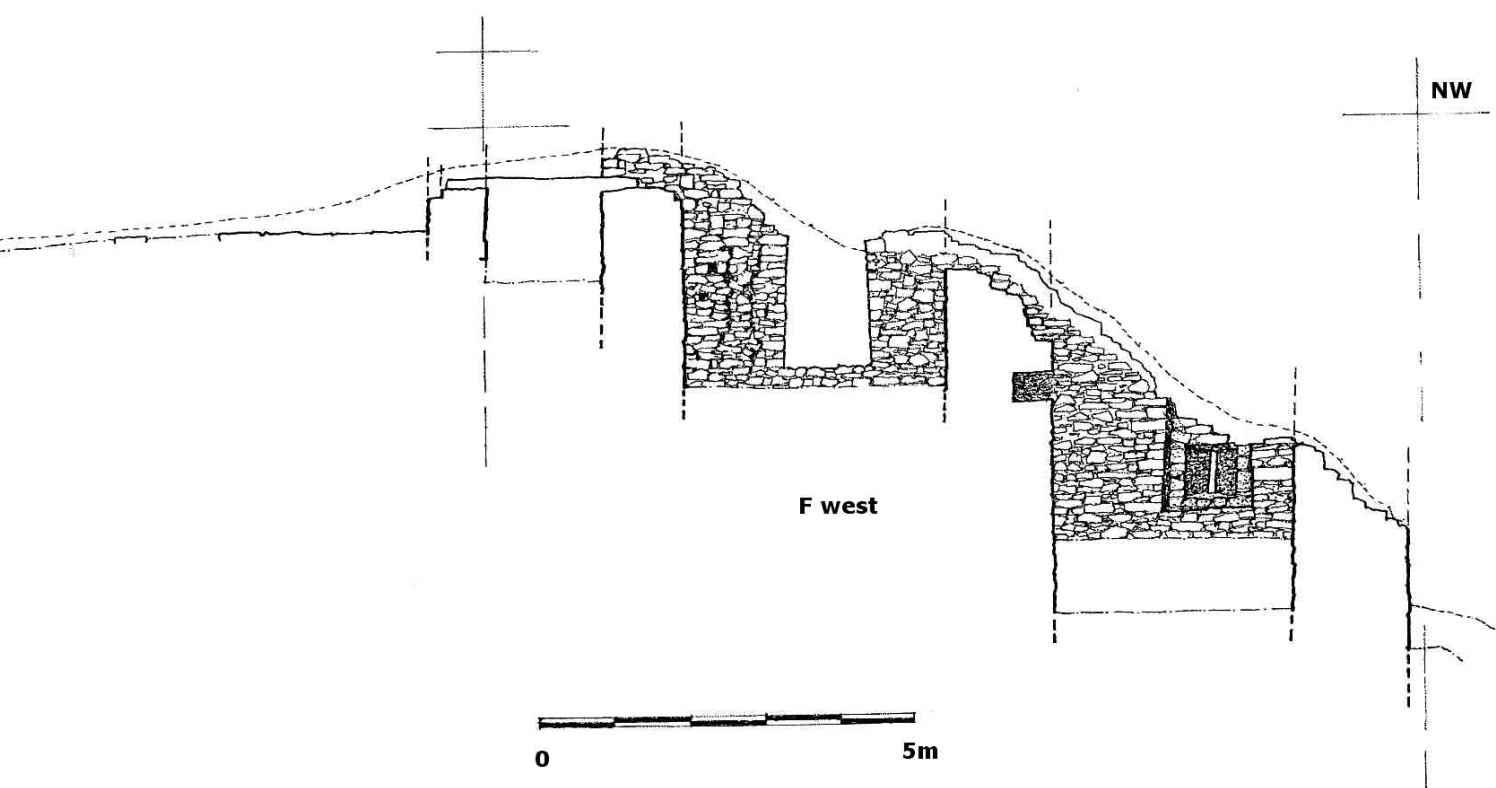
**Drapham Dzong 2008  
section - zone F**

Fig. 18 Section SE-NW through the main castle  
in zone F

The different rooms (Fa, Fb, Fc, Fd) were completely full of secondary debris. Under the secondary debris there was also primary debris with burnt remainders. It was impossible to reach the ground level within the whole area. The settlement layer in the rooms Fb and Fc with animal bones and ceramic findings seemed to be demolished from an upper floor.

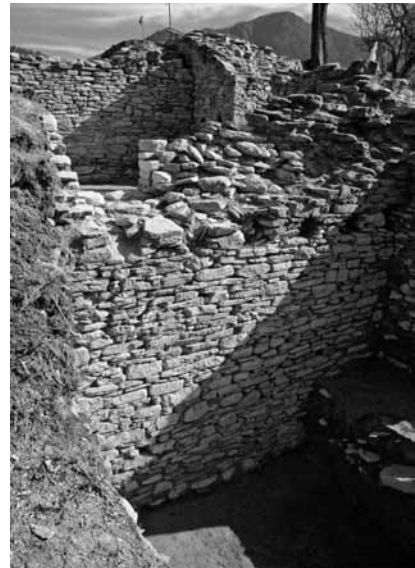
Fig. 19 Zone F west, inside the projected tower south-eastward with putlog holes  
Photograph: Werner Meyer

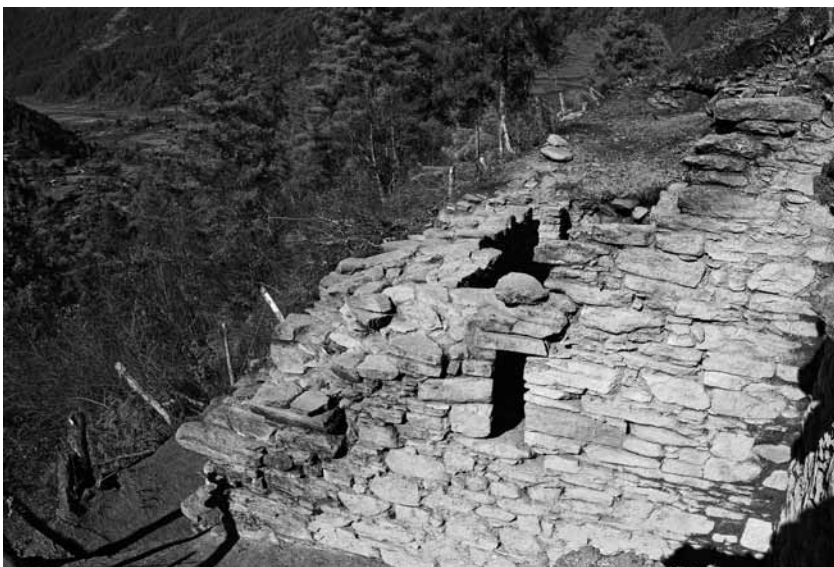
Fig. 20 Southern arrow loop in the projected tower in room Fc  
Photograph: Werner Meyer

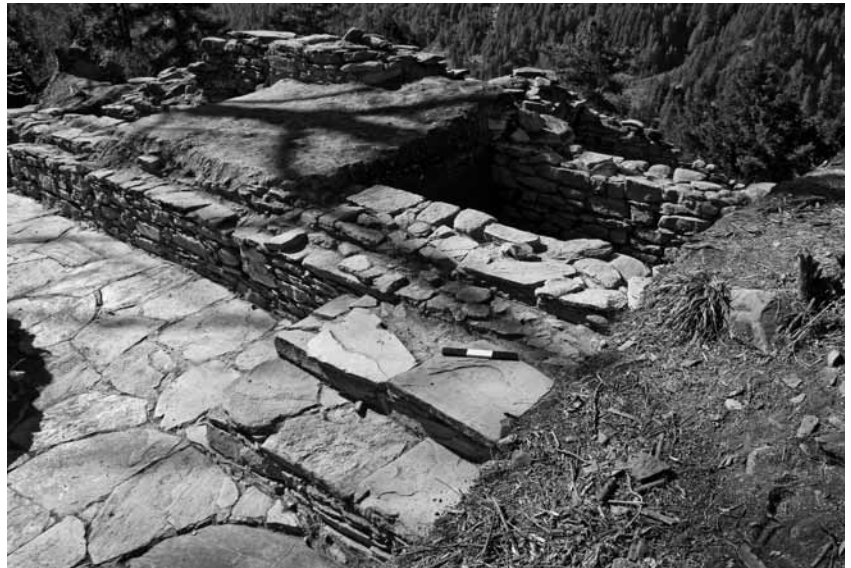
Fig. 21 Flagged floor in the inner courtyard with steps, behind loam floor of the corridor in zone F west  
Photograph: Werner Meyer

Until now, we found two types of artificially built floors. The first type is a flagged floor. The flagstones are irregularly shaped but very carefully tiled with little space in between. This type was used at ground level, e.g. in the central inner courtyard. The second type is an approx. 25 cm thick and multilayered loam floor which features small round pebbles of an average diameter of 3 cm. This type of floor was found in situ or parts of it in the primary debris from broken down upper floors. The intermediate floors were supported by parallel wooden beams. Their position was defined due to the putlog holes in the brickwork.

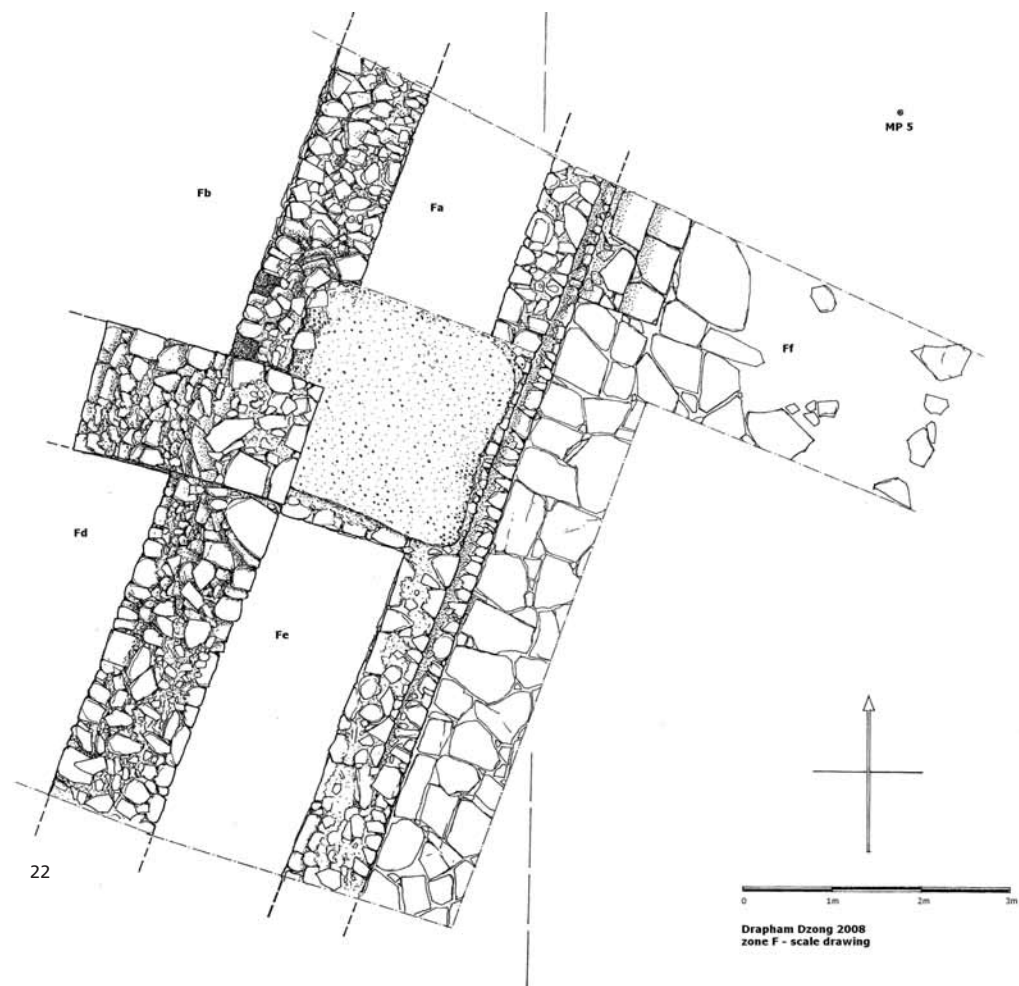
Fig. 22 Zone F west, inner courtyard with corridor  
Drawing: Werner Meyer and Silvia Scheuerer

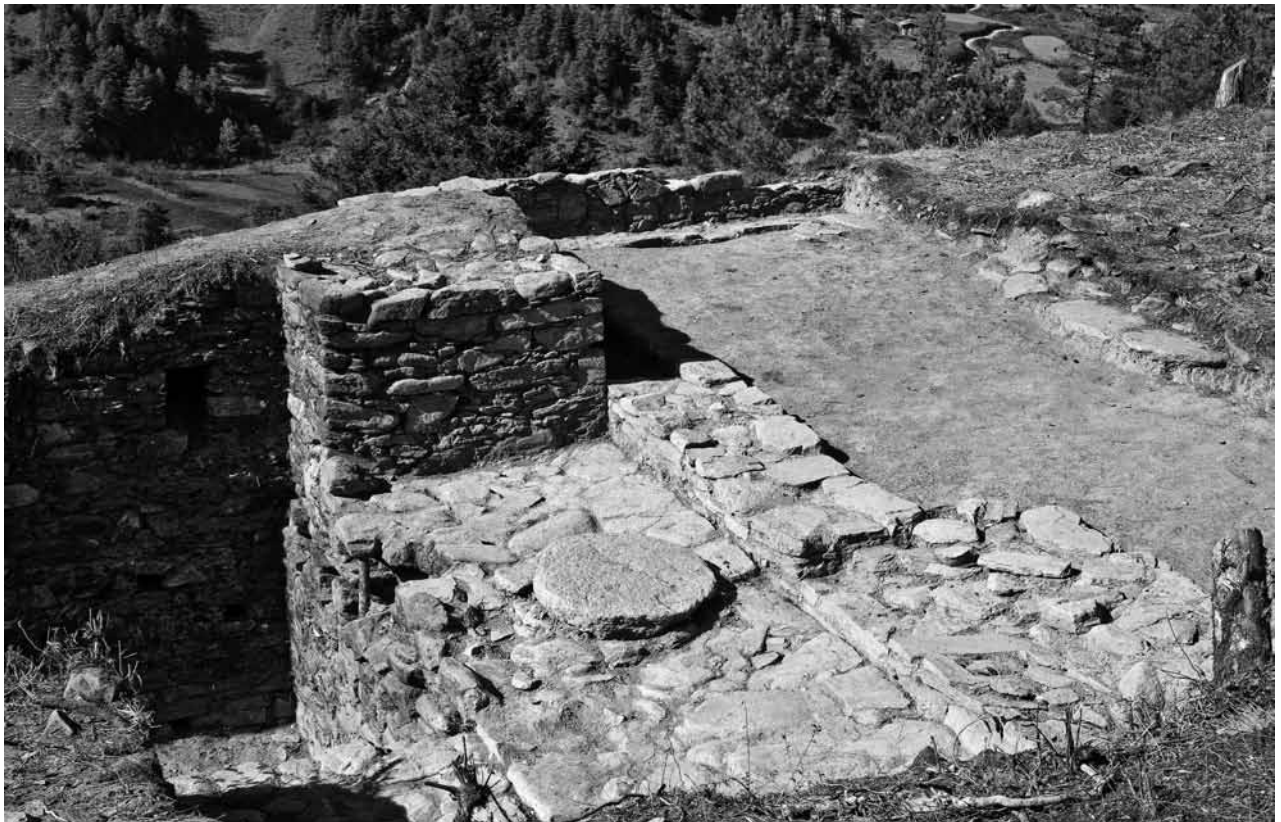
Fig. 26 Overview zone G  
Drawing: Werner Meyer, Kuenga Wangmo  
and Silvia Scheuerer

The excavation area G is situated at the southern end of the plateau. Here, the shapes of a rectangular building were visible before excavation. We were able to measure the entire outline of this building. It is a massive spiral construction ( $8 \times 12.5$  m) featuring wall dimensions of approx. 1.5 m. The building is divided by a transverse wall. The western section (room Gd) contains a lower cellar that is covered by a beam ceiling. It was impossible to reach the ground level of the cellar at this point. The eastern part (room Ge) had a loosely flagged ground level at the same height as the beams of the cellar in room Gd. On top of this ground level there was a thin humus settlement layer including a broken fireplace. In this settlement layer (complex G3) we found some ceramic findings.

The southern section of the inner courtyard (room Ga) traces this tower. The loosely flagged ground level is visible. We didn't discover a settlement layer in this part of the area.

Some walls were detected in the north-western corner of the tower Gd/Ge. These walls may well be attributed to the western building wing in zone F west and K. A narrow corridor alongside the courtyard (room Gb, identical to room Fa) and a room tracing the western side (room Gc) were verified. This room was built into the hillside. A line of putlog holes at the excavation level indicates an additional floor hidden deep beneath the debris.

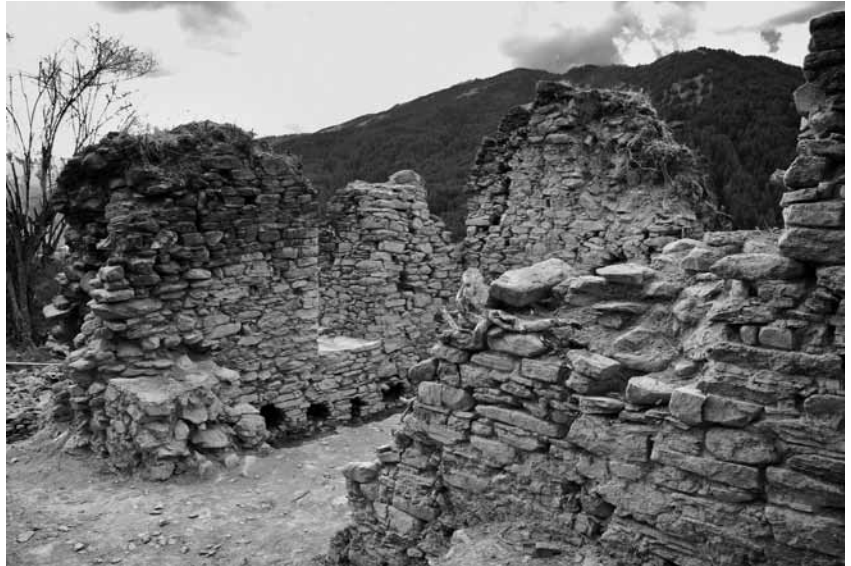
32

Fig.32 Inside the Utze zone T south-eastward  
Photograph: Werner Meyer

At the beginning of the excavation the masses of debris in room Ta were amassed in a heap up to the irregular degraded wall copings. In the western and southern walls, two large window cases with broken lintels were visible. We excavated this room down to the ground level of the floor where these two windows are located. A line of put-log holes in the southern wall of the Utze indicates that there must be another floor beneath the debris. Due to security reasons the excavation had to be stopped at this level. The brickwork of the Utze is seriously damaged. It is marked by vertical cracks

and, on the inner side of the wall coping, severe damages due to fire caused the stones to decompose. The northern wall of the Utze could hardly be found except for a few outwardly tilted or slumped wall fragments.

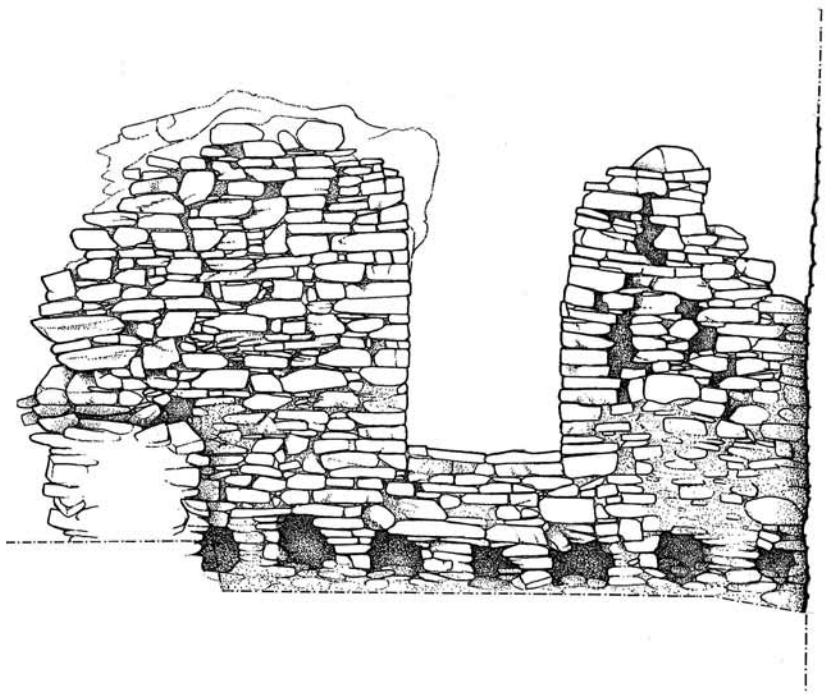
33

Fig.33 Utze zone T, wall W16c inside  
Drawing: Giovanni Buzzi

The excavation within the area of the Utze can only be continued if the brickwork is at least provisorily secured against collapse.

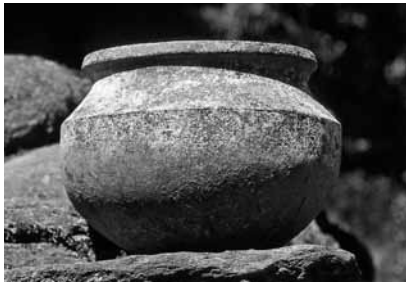
**Fig. 1** Village: Naspe  
Owner: Mrs. Pem Choeden  
*bar pi(t)*, Pot used to collect the distilled *ara* alcohol  
black clay, H. 16 cm, D. 18 cm  
«The pot was bought in Lhuentse dzongkak, more than 30 years ago»

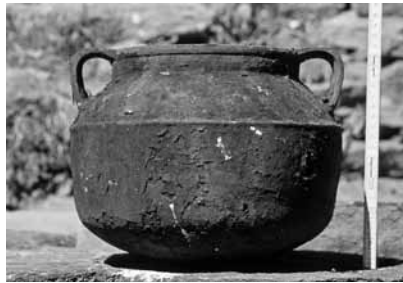
**Fig. 2** Village: Naspe  
Owner: Mrs. Pem Choeden  
*pit*, Handle pot for *ara* distillation from rice.  
H. 22 cm  
«It wasn't placed on a fire, it is sooty because it was stored in the attic.» – «My brother bought this pot in Lhuentse. In the past, men from here always went to Lhuentse to buy pottery. Previous to departure, the pots were ordered there. Many (female) potters used to work there (a generation ago). We haven't bought a single clay pot for more than 30 years.»

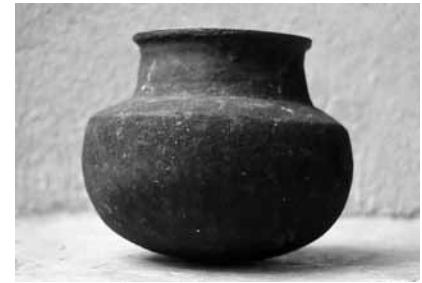
**Fig. 3** Village: Naspe  
Owner: Mrs. Dorji Lhamo  
*pit*, Pot for serving butter tea  
Red clay (sooted only on the outside) seems to be originally varnished.  
H. 17 cm, D. 13,5 cm

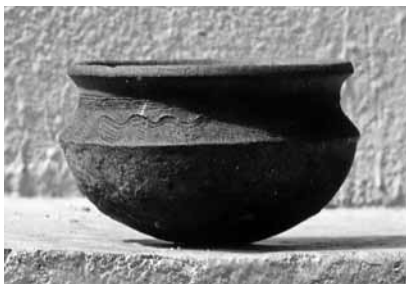
**Fig. 4** Village: Naspe  
Owner: Mrs. Dorji Lhamo  
*pit*, Pot for cooking vegetables  
H. 10,5 cm, D. 15,5 cm  
Ornamented with wavy lines and strings moulded into the neck. («Curry cooked in this pot was especially delicious!»)

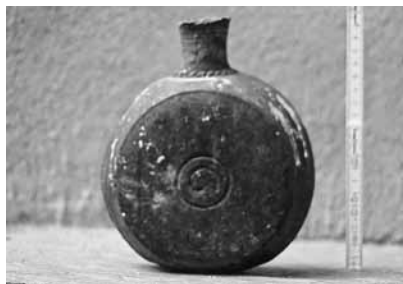
**Fig. 5** Village: Naspe  
Owner: Mrs. Dorji Lhamo  
*pergamachu*, clay flask for oil  
Stopper made of wood. With a flat base, it resembles copper vessels.  
H. 20 cm, D. 4 cm (underside: D. 17 cm)

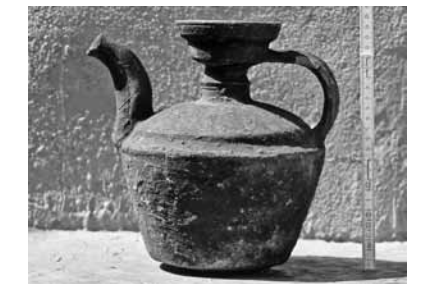
**Fig. 6** Village: Naspe  
Owner: Mrs. Pema Doma  
*chamji*, Spouted vessel, for serving tea  
Red clay, wave pattern on the top rim  
H. 24 cm

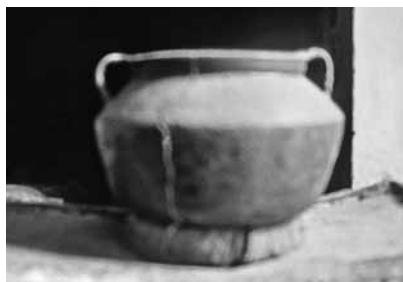
**Fig. 8** Ogyen Choling Palace Museum  
Handle pot  
H. 18 cm, D. 18,5 cm  
On the shoulder two grooves, lacquered (?), lip partly broken.

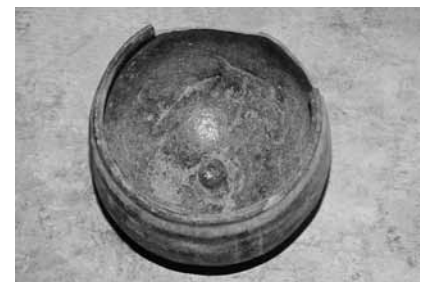
**Fig. 9** Ogyen Choling Palace Museum  
pot with a foot and a short pivot inside, on the bottom  
H. 16,5 cm, D. 18 cm  
High lip, black surface, red clay, lacquered (?)  
Usage unknown, possibly for *ara* alcohol distillation

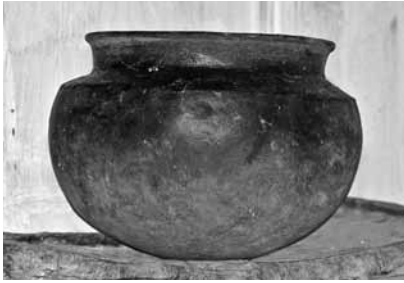
**Fig. 10** Ogyen Choling Palace Museum  
large vessel for the fermentation of cereals for the *ara* distillation  
D. 22 cm  
Inside reddish, outside black, thick coat of lacquer on the shoulder.

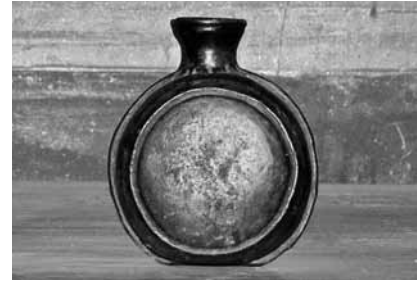
**Fig. 12**  
Ogyen Choling Palace Museum  
*ara* bottle, but possibly also for oil, to be carried in the folds of the *go*-coat  
H. 17 cm, D. 15 cm, spout 5 cm

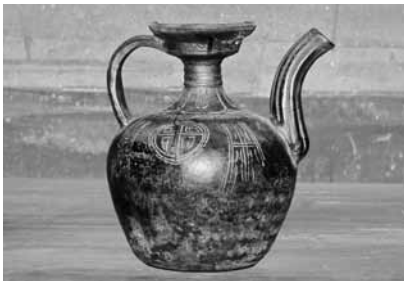
**Fig. 13** Ogyen Choling Palace Museum  
Teapot, richly ornamented  
H. 20 cm, opening D. 9 cm  
Fine earthenware, upper half red, lower part black. Probably imported from Tibet

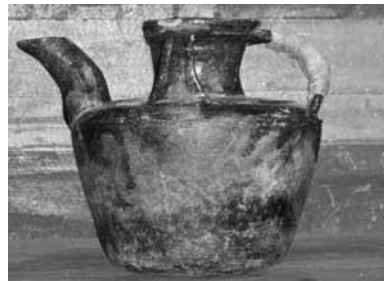
**Fig. 14** Ogyen Choling Palace Museum  
Glazed teapot  
H. 22 cm, D. opening 11 cm  
Handle covered with cloth, wooden cover, imported from Tibet

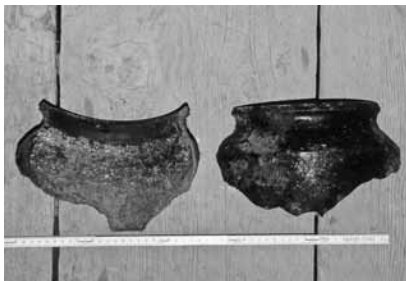
Fig. 19 Village: Ura  
Owner: Phuntsho Namgyel  
Two fragments of a pot for cooking vegetables  
black ware, rather thin ware (max. 3 mm thick)

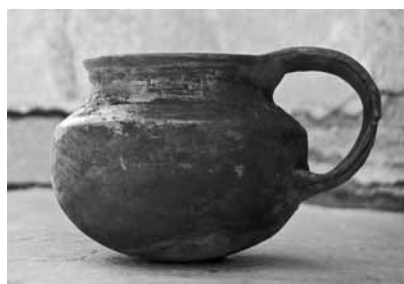
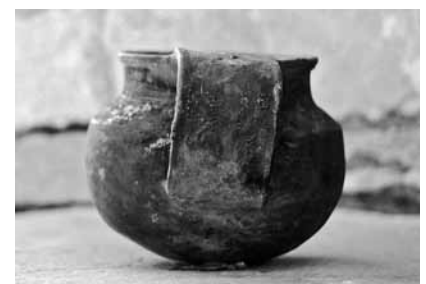
Fig. 22a Village: Shingkhar  
Owner: Mrs. Jigme Choden  
*Saoli*, pot with broad handle, was used to feed a baby  
H. 14,5 cm, D. 13,5 cm  
Inside red, outside black, traces of lacquer  
«The pot was bought approx. 40 years ago. At that time, our grandfather went to Gangzur in Lhuenzi and bought pots there.»

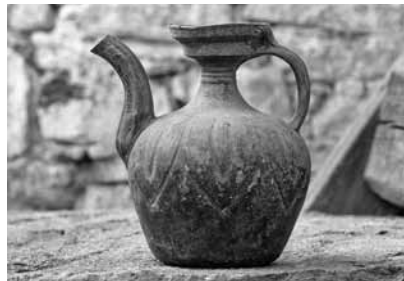
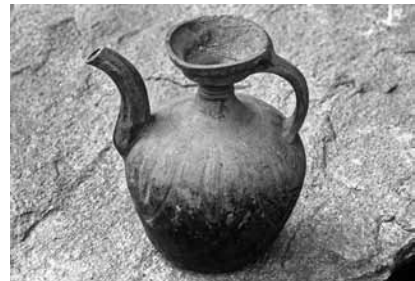
Teapot with handle and spout, fired red, in parts lacquered black, rim repaired. On the shoulder lotus petals, engraved leaf shapes, spout and handle heavily decorated, patterns slightly raised.
