## **Bhutan-Swiss archaeological excavation project 2008–2010 Drapham Dzong, Bhutan. Report 2009.**

### **Introduction**

The Drapham Dzong is located in the Bumthang district in Central Bhutan on a mountain ledge in the Chamkhar Chhu valley (exact position: N 27° 39' 15.4", E 90° 45' 14.9", height: approx. 2,930 m.a.s.l.). The elongated mountain ledge is steep on all sides and in places, the rock forms the foundation of the wall. An ancient valley path leads across the col, east of the fortress hill.

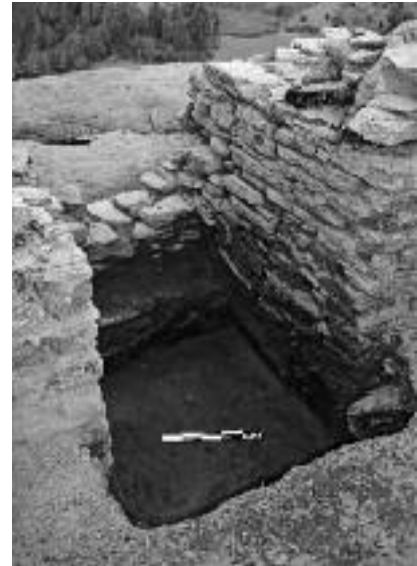
Fig. 13 Area Tc, arrow slit in the north-eastern wall of the Utse. Photograph: W.M.

As expected, the arrow slits were discovered at the periphery of the upper castle, in the curtain walls and on the towers. Both the Utse and the south tower featured arrow slits on the ground floor – they were probably designed for ventilation and lighting rather than for defence purposes.

The interior arrow slits were all built according to the same pattern: rectangular chambers, as tall as a man, with enough space for an observer or a shooter. The arrow

loop was shaped conically and usually tapered off to a narrow, approx. 10 cm wide and 50 cm high slit that broadened out at the bottom. These slits were built for archers to shoot arrows. Tests using a recent, traditional bamboo bow showed that per slit, a lateral shooting angle of 40° and a vertical, downward angle of 35° were possible. At the north-western corner tower E there are also horizontal, rectangular slits which, analogous to occidental forms of such slits, lead us to classifying them as light-calibre firearms.

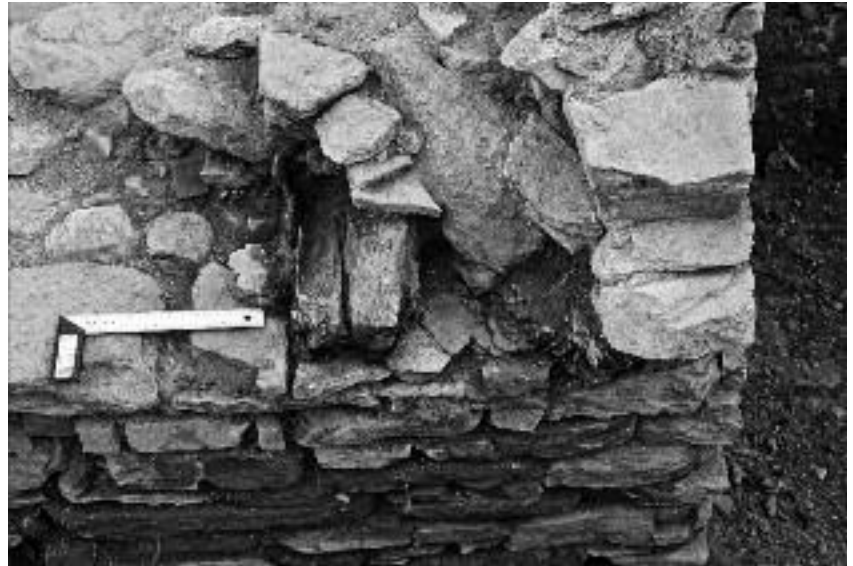
Fig. 14 Area Tc, remainders of the summer beam in the embrasure of the arrow slits. Photograph: W.M.

In 2009, we were able to record and document the wooden elements (embedded in the brickwork) in a more distinct and precise manner, particularly in the area of the Utse (sector T). The wooden parts – the lintel beams above the doors and windows – proved to be structural weaknesses because all of these beams were either burned or decayed which is why the brickwork above – without a safety arch – had no means of support. The disastrous condition of the Utse and other buildings can be explained by the collapse of the sections of the wall where the wooden supports were removed.

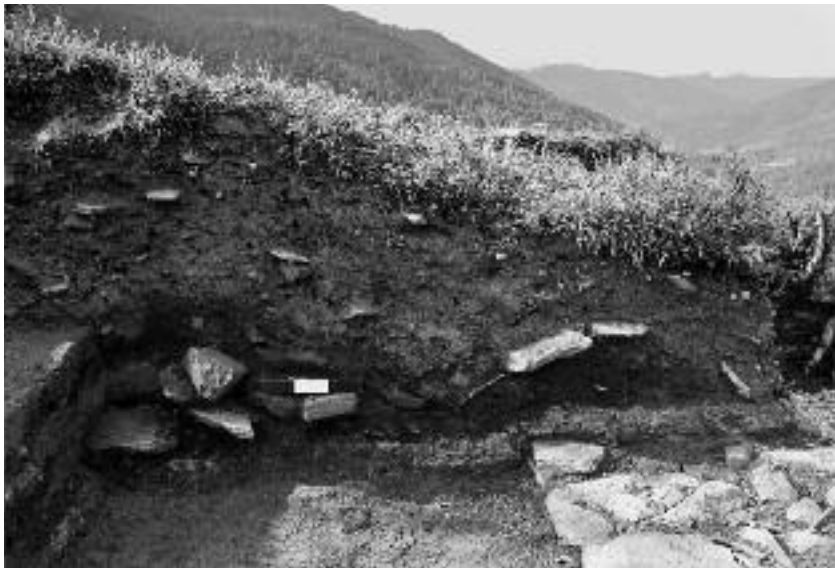
**Fig. 17** Area Gh, layer profile with collapsed hearth. Photograph: W.M.

Inside the south tower and on its forecourt to the north (which belonged to the courtyard), the excavation zones were extended in 2008 in order to thoroughly expose the finds. In area Gh, the precipitated, central hearth was investigated; in its burnt layer, fragments of ceramics were allocated to the same type A which had already defined the consistency of the ceramic material in 2008.

Next to or beneath the debris from the blaze – which spreads across an area of approx. 5 square metres – a very weak occupation layer containing humus (practically without any finds) emerged inside the south tower upon an artificial floor of limestone and clay.

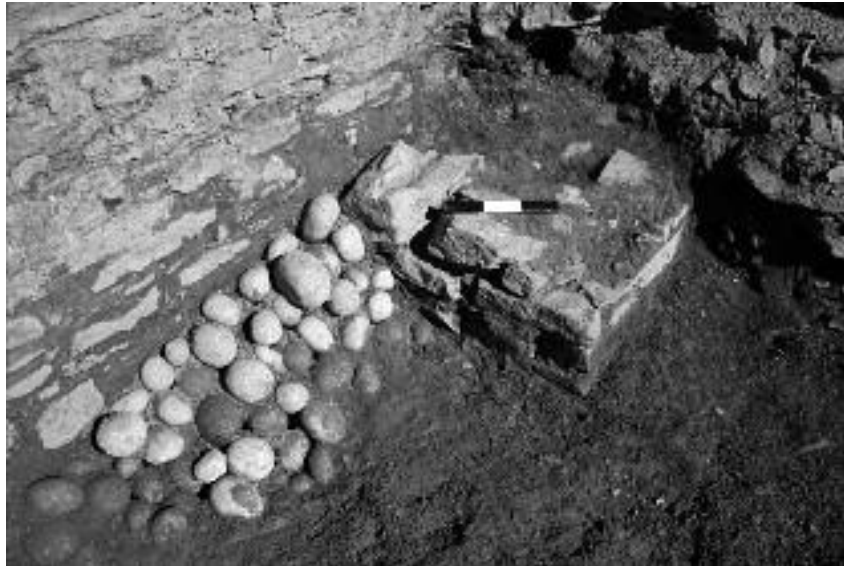
Fig. 36 Area Ua, gravel deposit at the foot of the Utse. Photograph: W.M.

A peculiar find emerged at the foot of the Utse. A square wall block (each side: 1 m) was found leaning against the outer front, below a narrow slit. A depot containing several hundred pebbles was discovered on both sides of the block. The pebbles were specially picked and were round-shaped with a diameter of approx. 10 cm. Except for several samples retrieved for material analysis, the depot remained untouched for the time being. The function of the pebbles, some of which were painted red, remains unclear at the moment.

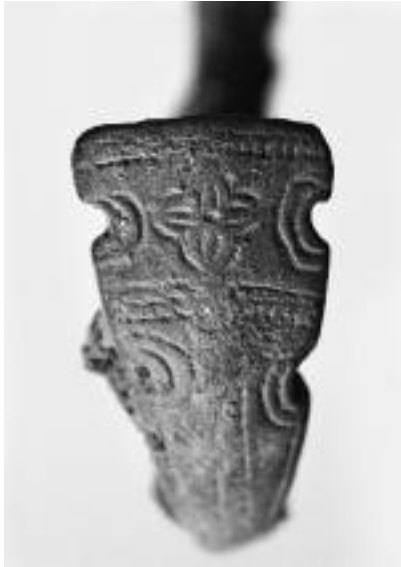
Fig. 38 Small finds, fragmented bangle made of non-ferrous metal. Photograph: S.S.
