The Bhutan-Swiss Archaeological Project **The fortification Drapham Dzong in Central Bhutan**

Werner Meyer (in collaboration with Eberhard Fischer and Jorrit Britschgi)

This preliminary report defines the conditions and aims for a first major excavation at the Drapham Dzong site in Bumthang District, Bhutan. The overarching project, however, encompasses several sub-projects. The Bhutanese representatives and the Swiss team agreed upon the name «The Bhutan-Swiss Archaeological Project» to institutionalize several joint undertakings. This title emphasizes the urgent need of the Royal Government of Bhutan to turn archaeology into a permanent field embedded in the framework of the administration. Our collaboration includes at least three major goals:

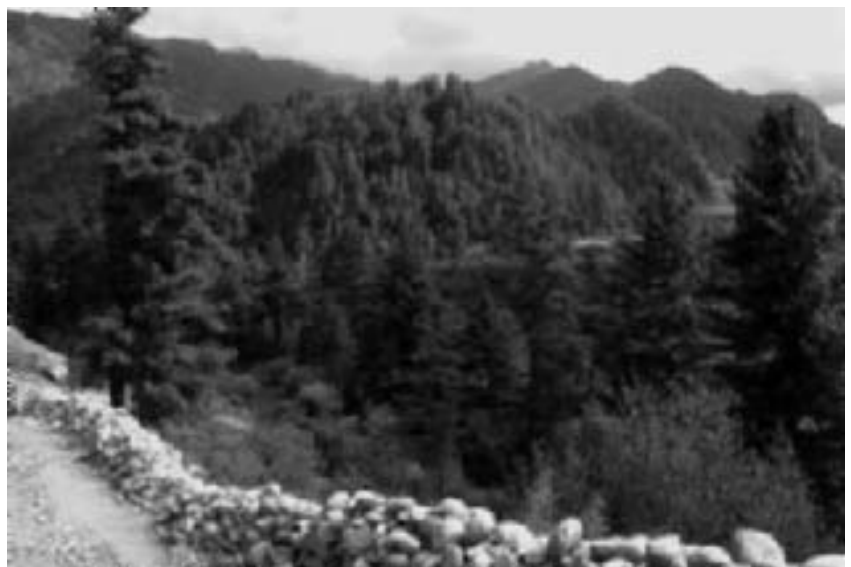
Fig. 1 Distance view of the Drapham Dzong
Photo: Werner Meyer

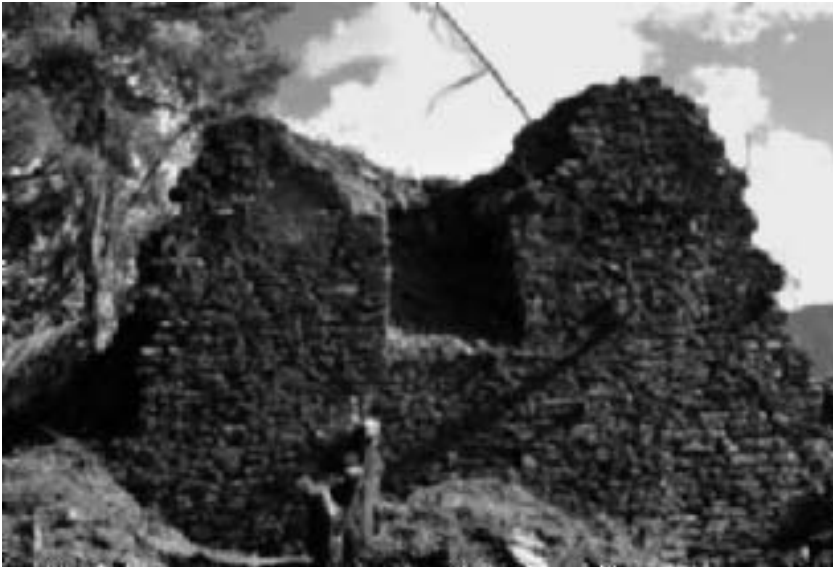
Fig.4 Western Wall of the main tower (pos. 1)
Photo: Werner Meyer

On the longitudinal axis of the area: remains of a building similar to a tower. The whole building stands on a hill of debris of up to 4 meters. Estimated dimensions of the ground plan: 12 to approx. 18 m. Western area: parts of walls of up to 6 meters. Eastern area: mostly buried under debris, modern disturbance by a recently built hut of a hermit. Opposite the longitudinal axis of the plan, the building is sloped by approximately 10 degrees.

Inside filled with debris. Traces of two transverse partitionings. The outside walls are 1.7 m thick, the outer bevel wall sheath from 30 cm to 6 m height. North, west and south parts of the wall of the western area with several openings of 1 to 1.4 m width at the height of the presumed first floor. The outmost part of the bond at the southwest and northwest corner obviously destroyed up to the wall footing.

The original height of the building is not determinable. The large masses of debris presume at least 3 to 4 floors. Apparently the building stood isolated. Anyhow, no connecting walls are visible. Because of the dimensions, the building of position 1 seems to be the main building of the core area.

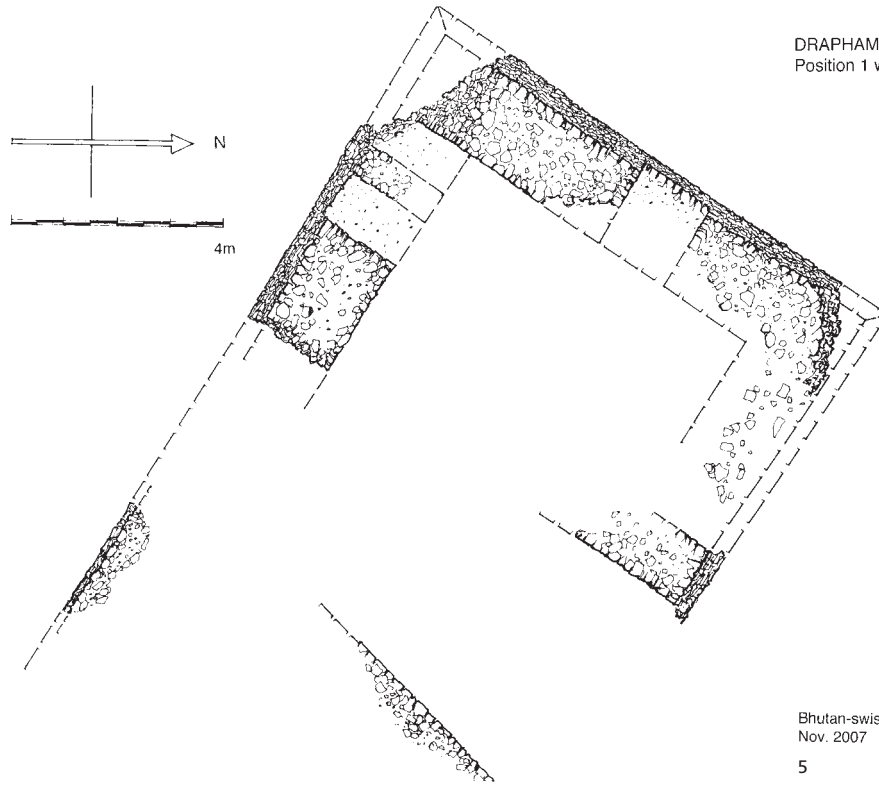
Fig.6 Plan of the the remains of the main tower (pos. 1)

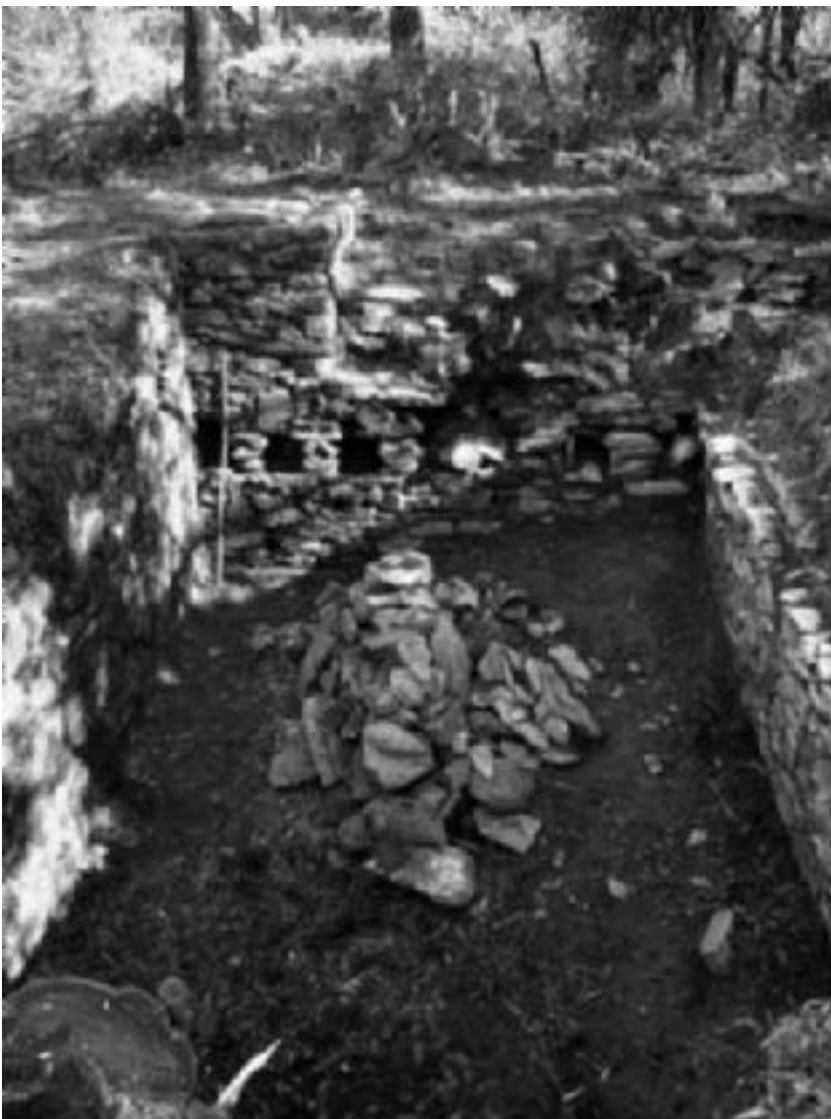
Fig. 7 Remains of a building at the southern end of the plateau (pos. 5)

Remains of a rectangular building at the southern edge of the plateau which is oriented transverse to the longitudinal axis. Only the western part is visible. Dimension of the wall, as far as assignable, 1.6 m. The preserved wall covers a room which is built approx. 2 m into the soil like a cellar. Entrance in the northern wall. Putlog holes on the northern and southern narrow side show the level of an intermediate floor (sampling pieces of wood for radiocarbon dating nr. 4). The wall coping of the eastern wall on the length side of this deeper area only reaches up to the level of this intermediate floor. Above the wall coping informative pattern of strata with humus settlement deposit (sampling for radiocarbon dating nr. 1–3). Above this settlement layer, a layer of mortar screed of limestone (supplement 4). The eastern part of the building buried in debris. No traces of connecting walls.

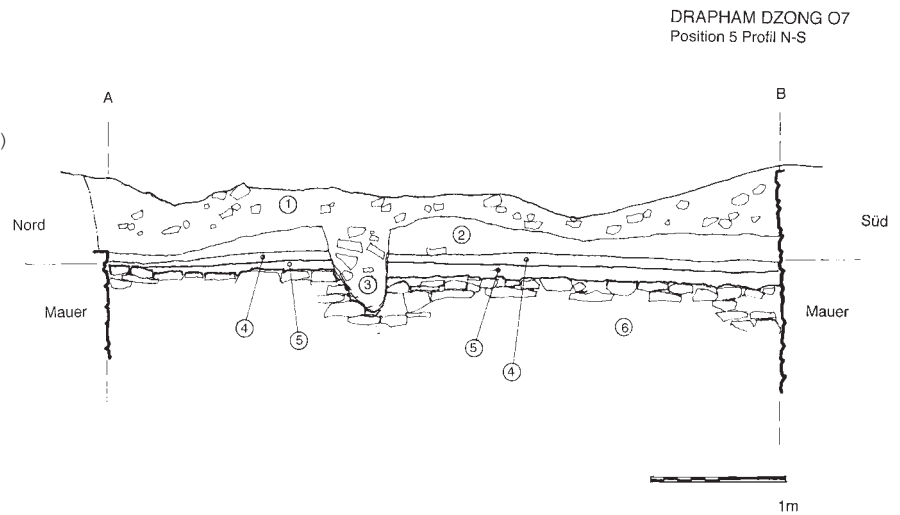
Fig. 8 Layer profile position 5

- 1 Waldhumus
- 2 Störung
- 3 Gelbrauner Lehm
- 4 Weisser Kalkguss
- 5 Schwarzbraune Siedlungsschicht, ¹⁴C-Samples 1-3
- 6 Mauer und Bindemittel

The actual situation of the ruin area figures on build-historical surprises in case of an excavation. Probably the building of position 1 was constructed later or was used longer than the other buildings. And what does the mortar layer above the settlement-stratum in position 5 mean?

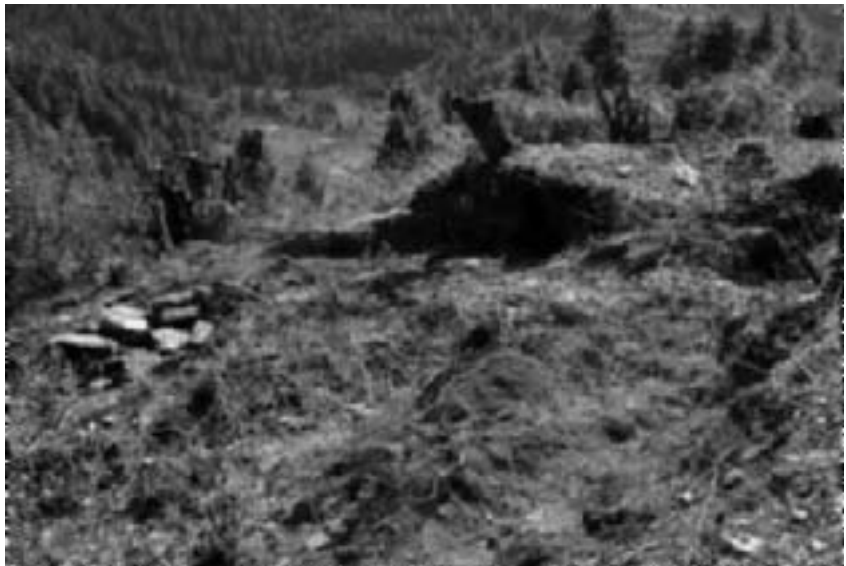
Fig. 12 Part of wall of a building leaning inside to the eastern fortified wall (pos. 7)
Photo: Jorrit Britschgi

Small part of wall of the building leaning inside to the eastern fortified, unveiled at unknown time. Dimension of the wall 0.9 m. Wall sheath partly broken out. To the western wall coping a small, not interpretable piece of wall meets with a butt joint (appendix 5).

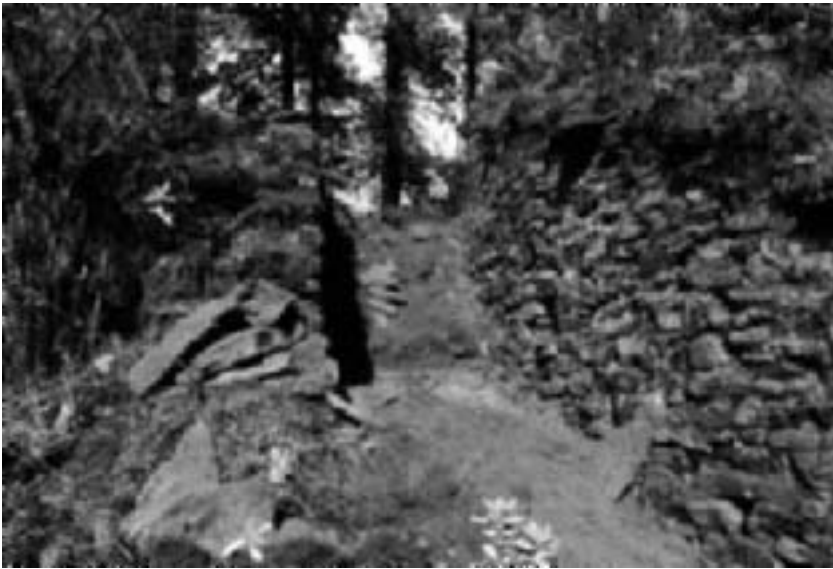
Fig. 16 Excavation of position 5
Photo: Jorrit Britschgi

i.e. inside the fortified wall, traces of an elongated, multiply transverse divided part, which is built out from the western slope of the plateau. A transverse wall with a doorway. In direction of the court, traces of a narrow, passage-like porch. Northern and southern delimitation of this part not assignable.

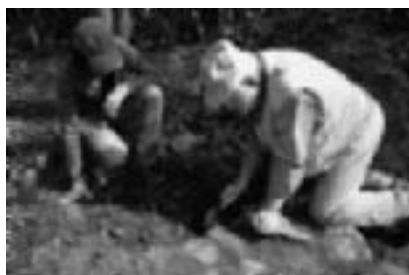
Eastern fortified wall with an elongated, hardly recognizable building inside leaning against it. A small wall fragment suggests a transverse partitioning. The yard-lateral longitudinal wall of the building seems to aim at the southeastern corner of the building of position 1.

The fortified wall can be well pursued on the whole length on the exterior side. Restored height of 0.4–1 m. Dimension of the wall not clearly definable, at least 1.6 m. Wall line with straight process. In the northern part, a remarkable opening of approx. 30 cm width, function unknown.
