**Chubjakha Dzong Ruin, Paro Dzongkhag, Kingdom of Bhutan**  
**The Investigations in 2013**

Christian Bader, Sonam Tobgay, Sangay Kinga, Karma Tenzin

*Chubjakha Dzong Ruin*

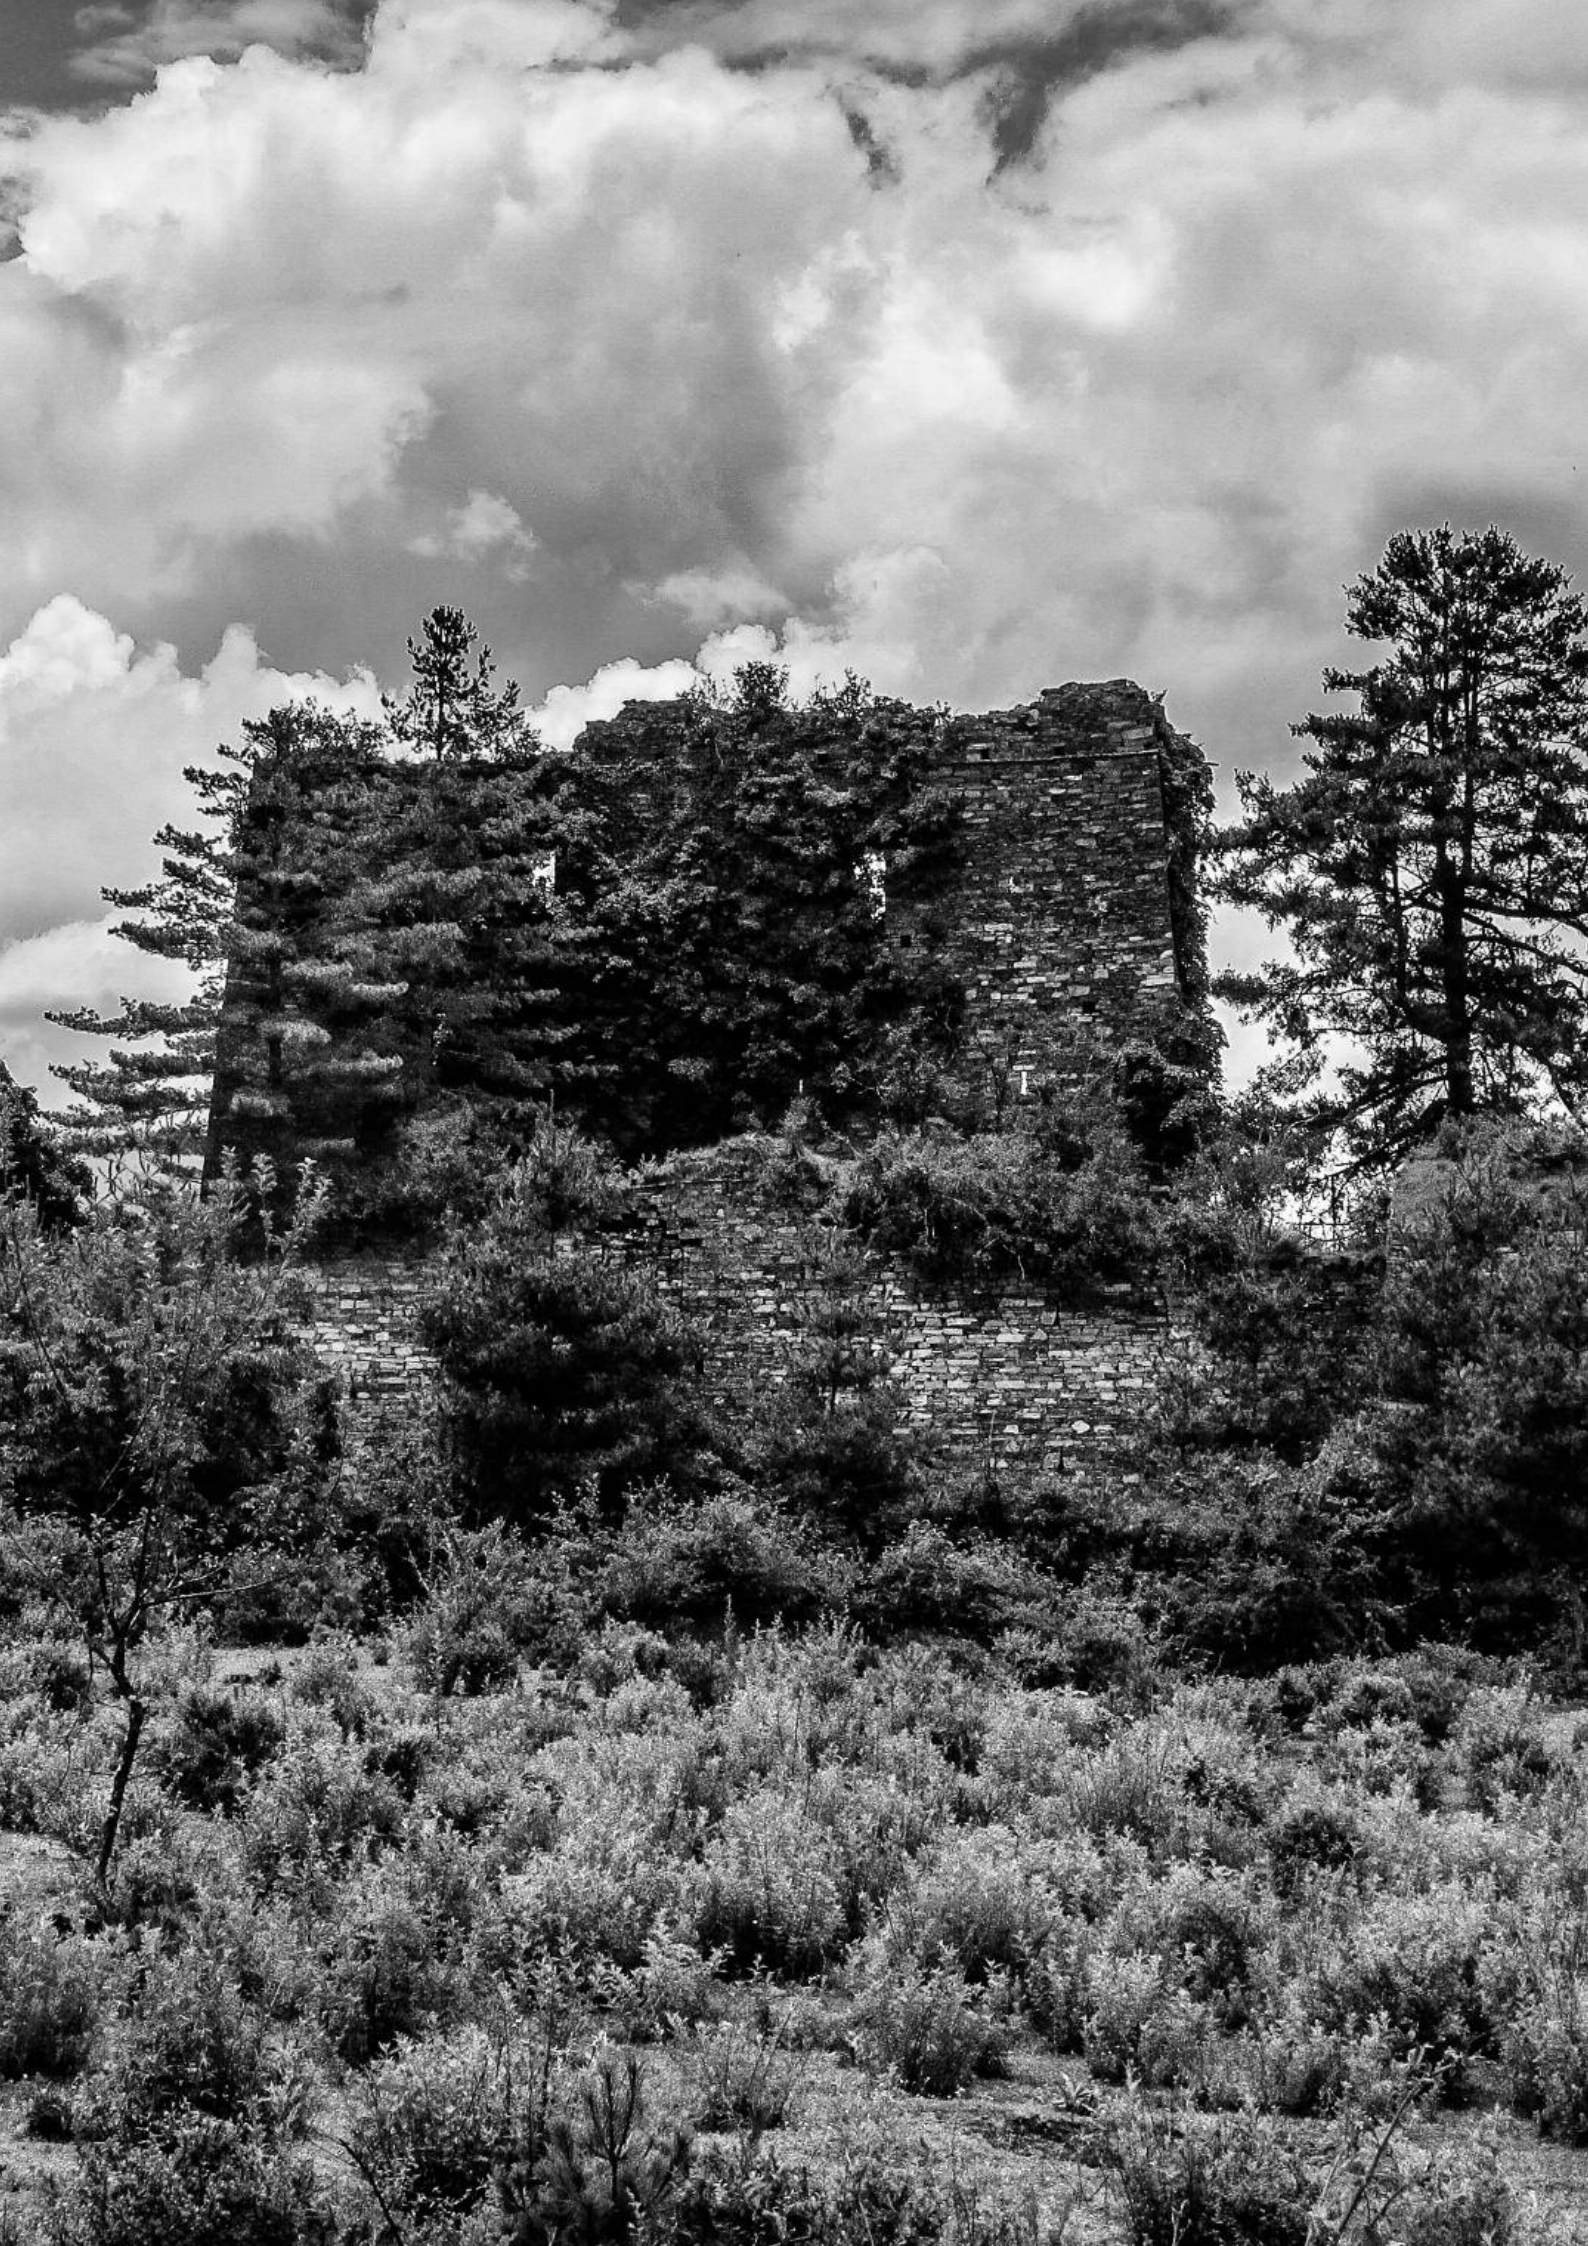
Fig.1 Chubjakha Dzong, Paro Dzongkhag, Bhutan. View of the ruins from the east. The main tower is at the centre (Utse).

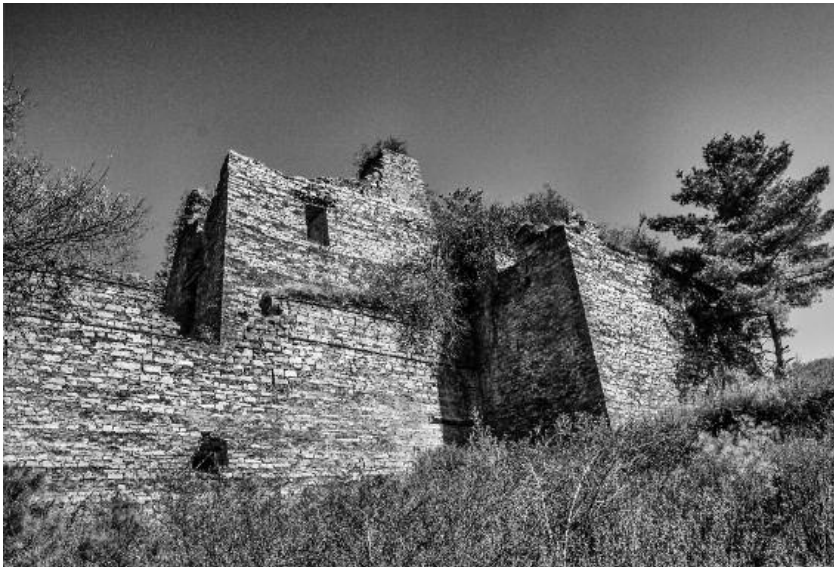
Fig. 6 Chubjakha Dzong, Paro Dzongkhag, Bhutan. View of the enclosing wall and tower 4 from the southwest.

The central facility of the Dzong is a rectangular fortress with a side length of approx. 40 m. It encompasses rectangular fortified towers at each corner (Fig. 3). The enclosing walls to the north, east and south are all built from the local plate-like split rocks (Fig. 6; 7; 11). The up to 3 m thick wall is an exceptional piece of high-quality work. The rather flat stones were alternately laid as stretchers and binders, and the wall is solidly built from the inner to the outer wall casing. Mortar was used as a binding agent. The enclosing walls are largely preserved up to the cornice (which used to be red) of the so-called *Kemar* at an approximate height of 6 m.

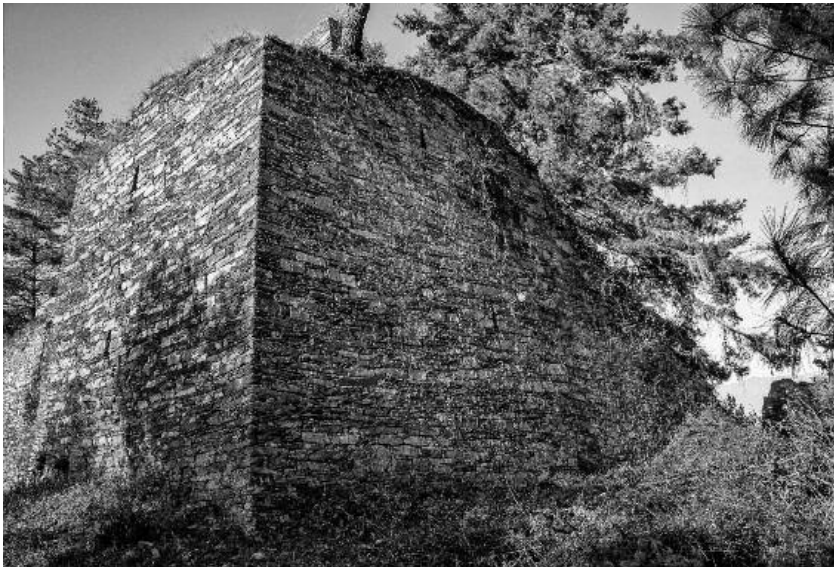
Fig. 7 Chubjakha Dzong, Paro Dzongkhag, Bhutan. View of towers 3 and 7 from the north.

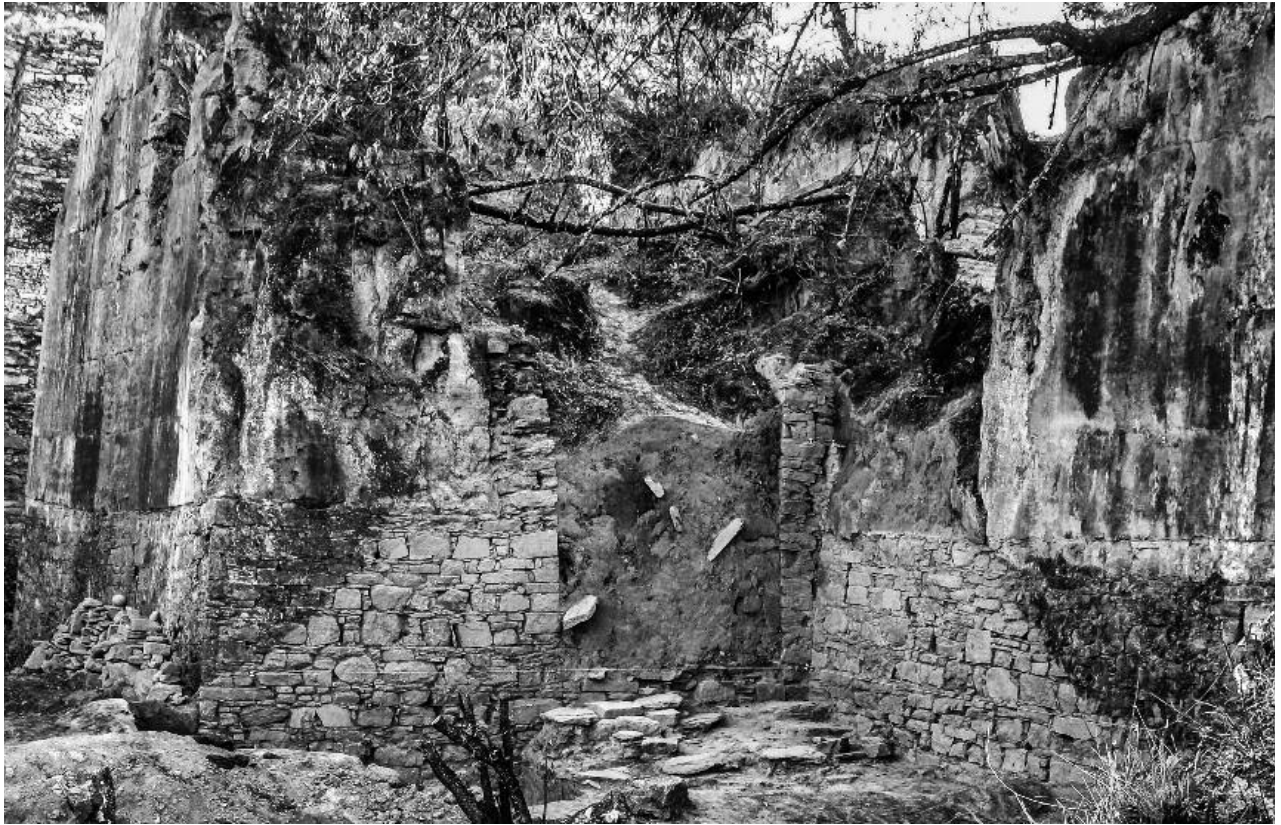
8

**Fig.8** Chubjakha Dzong, Paro Dzongkhag, Bhutan. The evaluation area in the corner of walls 12 and 13 featuring the excavated main entrance. View from the southwest.

A deviating construction method displays the section of the enclosure that points toward the slope in the west between the corner towers 5 and 6. These are walls 12, 13, 14, 15 and 16 (Fig. 8; 9). They have a 2 m high foundation made of stone and, above, rammed earth walls which are at least 2 m thick. The rammed earth walls are 1.5 m thick and were built in a modular manner. The finding clearly shows a box height of 75 cm per work step. Both the foundation as well as the mud walls are very well preserved. Respectively, along the base of the wall there is little debris. One exception however is wall 13 resp. the corner of walls 12 and 13. Here lies a huge scree. Due to

the fact that no other gate construction is visible in any other area of the enclosing wall, the entrance could only be postulated here. A stone battlement 13.3 is considered a positive indication – its interpretation was verified as a western gate frame during the excavation (cf. 4.2 The archaeological evaluation of the entrance area).

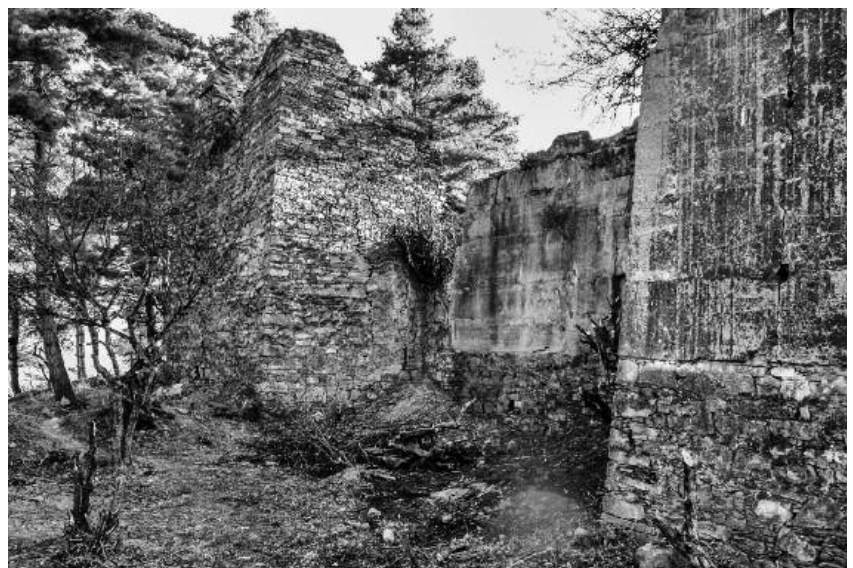
9

**Fig.9** Chubjakha Dzong, Paro Dzongkhag, Bhutan. Tower 6 and the western sections 14 and 16 of the enclosing wall made of rammed earth. View from the west.

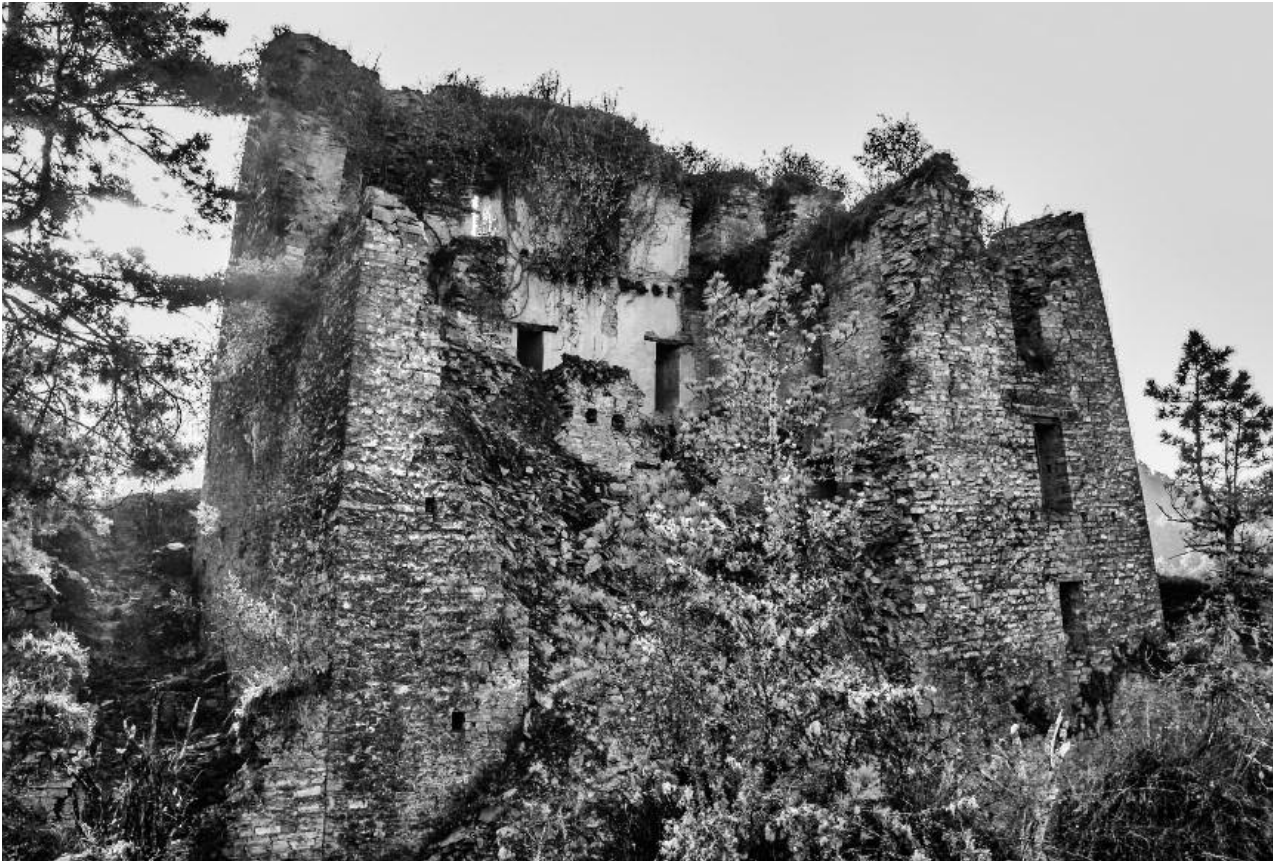
10

earthquake in September 2011<sup>3</sup>. The thickness of this west wall is only 2 m, and here is where the entrance to the Utse was located, as well as a *Rabsey*, a balcony that extends over several stories. Today, it is possible to climb over the wall segment that tipped over and enter the interior of the Utse, hence reaching the second floor. A complex internal division comprising several rooms is visible here.

**Fig. 10** Chubjakha Dzong, Paro Dzongkhag, Bhutan. View of the Utse from the north.

The interior of the Dzong is dominated by the mighty Utse (1), the rectangular main tower featuring 15×20 m long sides and approx. 3 m thick walls (Fig. 10). The walls in the north, east and south are five stories high, preserved up to a height of approx. 12 m, and, as common with Bhutanese stone buildings, the walls clearly lean inwards. The west wall facing the valley has collapsed – the entire wall segment had tumbled over as an intact stone bonding. Here, it appears that the damage was caused by the

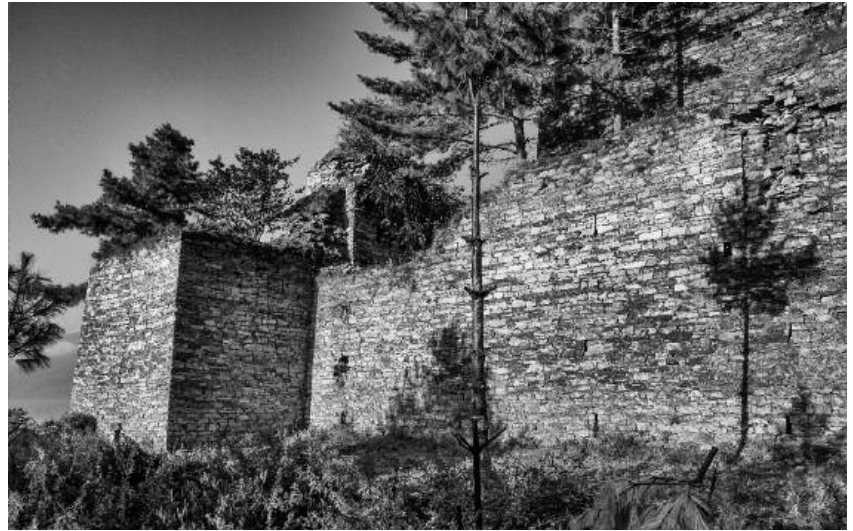
Fig. 11 Chubjakha Dzong, Paro Dzongkhag, Bhutan. Buildings from a recent period. The latest tower 8 and defensive wall 10 attached to the older tower 4. View from the east.

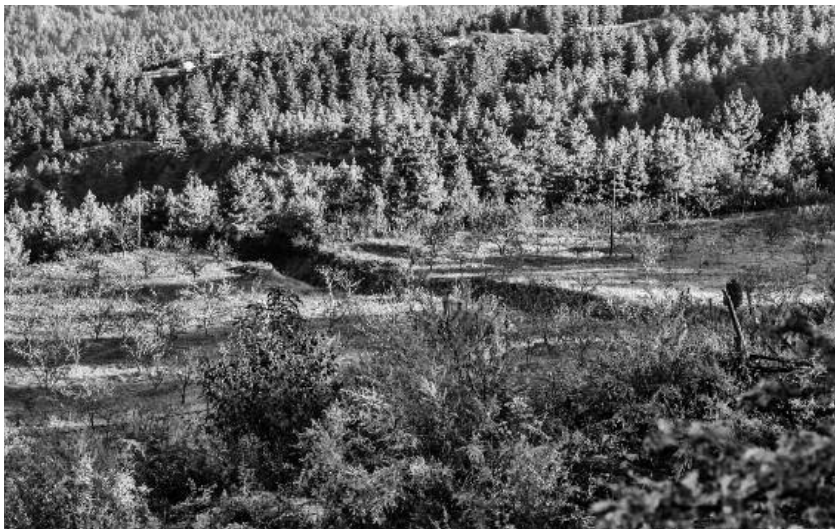
**Fig. 12** Chubjakha Dzong, Paro Dzongkhag, Bhutan. Trench 25 in the area of a terrace to the north and beneath the Dzong ruin. View from the west.

The Chubjakha Dzong was built on a terrace between two natural trenches that were originally aquiferous. According to the topographic map of Bhutan (scale: 1:50'000), a stream arises south of the Dzong, runs off to the west and joins Pa Chhu beneath the Paro Rinpung Dzong near the Nemezampa (bridge). A further stream originates northeasterly of the Chubjakha Dzong, at first flowing in a northwesterly direction, and finally turning towards the west and joining the Deo Chhu. Both trenches were used for reinforcement purposes and then developed into two semicircular moats – one behind the other – which led around the Dzong area.

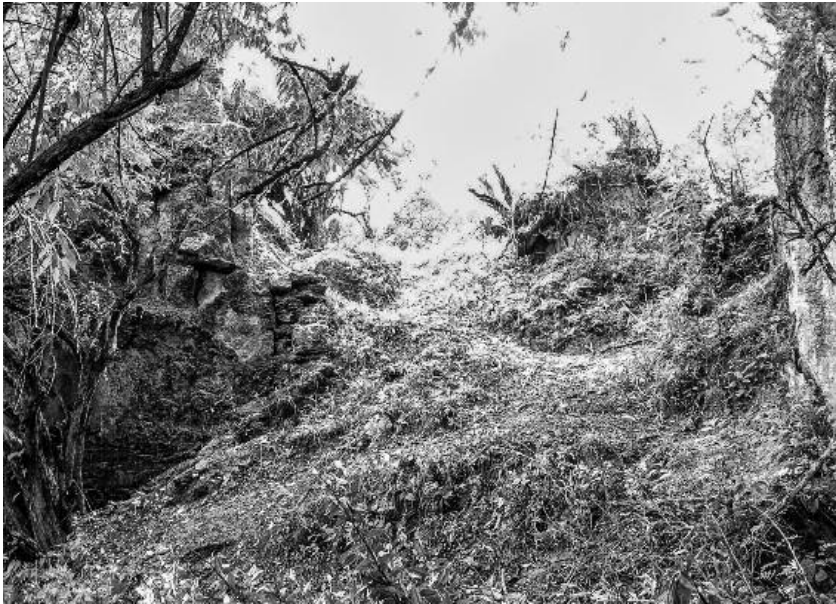
17

**Fig. 17** Chubjakha Dzong, Paro Dzongkhag, Bhutan. Investigation site 33 before commencing work.

In the first instance, the entire corner area of walls 12 and 13 were freed of vegetation (Fig. 17; 18). Afterwards, strings were attached along the alignment of wall 13 and 1 m parallel to the alignment of wall 12 in order to mark the profile axes. After that, we started to remove the earth along the marking strings (Fig. 19). This material (33.7) consisted of the debris from a rammed earth wall. During the removal, a profile of the scree was created parallel to wall 12. At the same time, larger parts of the foundation 13.2 became visible. The battlement 13.3, which had become visible at the top before the start of the excavation, emerged as the remains of the western gate frame (Fig.

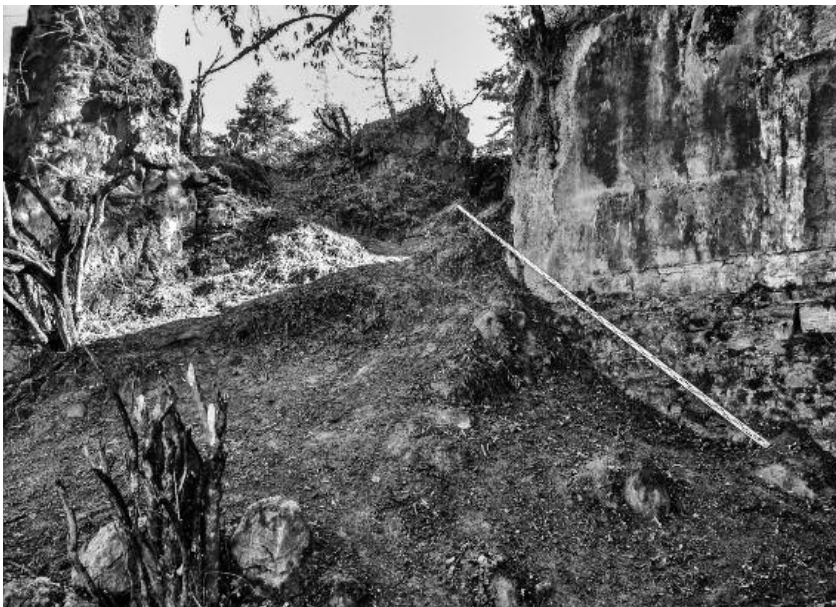
18

**Fig. 18** Chubjakha Dzong, Paro Dzongkhag, Bhutan. Investigation site 33 after grubbing up the vegetation.

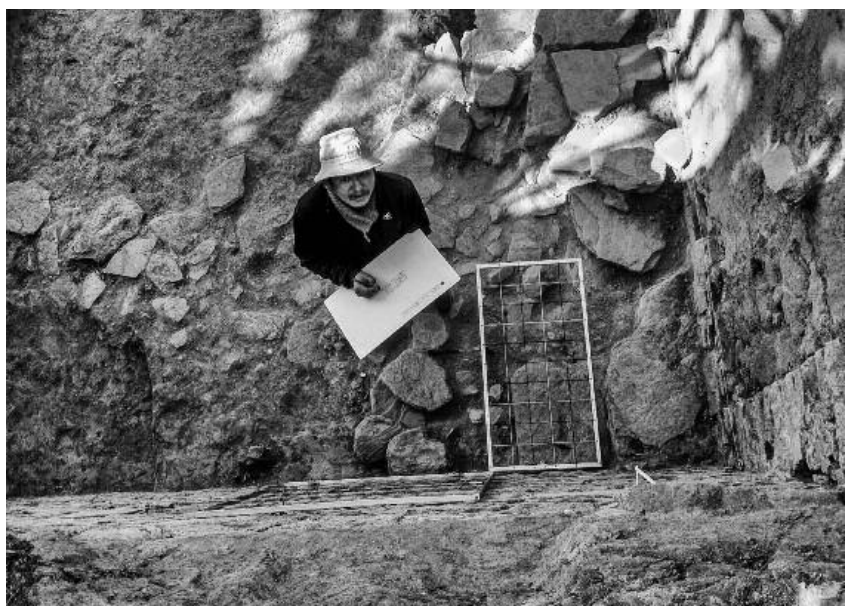
20

Fig.21 Chubjakha Dzong, Paro Dzongkhag, Bhutan. The evaluation area 33 with paving 33.4 and staircase 33.5 to the entrance of the Dzong.

25). At the height of the gate threshold, we stopped removing the earth, and instead documented the profile which ran parallel to wall 12. We then removed the earth down to the same level. This is where the eastern gate frame 13.4 then emerged. During the further removal of the debris 33.7, remains of a staircase 33.5 leading to the gate as well as a stone slab floor 33.4 were exposed (Fig. 21). The stone slabs were apparently only laid within the area of the access paths. Next to it, the paved surface area was made of a fill resp. an encasement consisting of small stones 33.3 (Fig. 21). The aforementioned paving rests on a unit of hard and compacted clay 33.2. This layer was evaluated in one single position measuring  $50 \times 50$  cm. It was traced down to a depth of 30 cm, but its bottom edge could not be reached. For this reason, the thickness of this layer package is still unknown. This was obviously material which was used to level off the terrain between the defence wall 29 and the western Dzong enclosure (12–16) and then deposited here. The material with a loamy matrix was strongly mixed with charcoal.

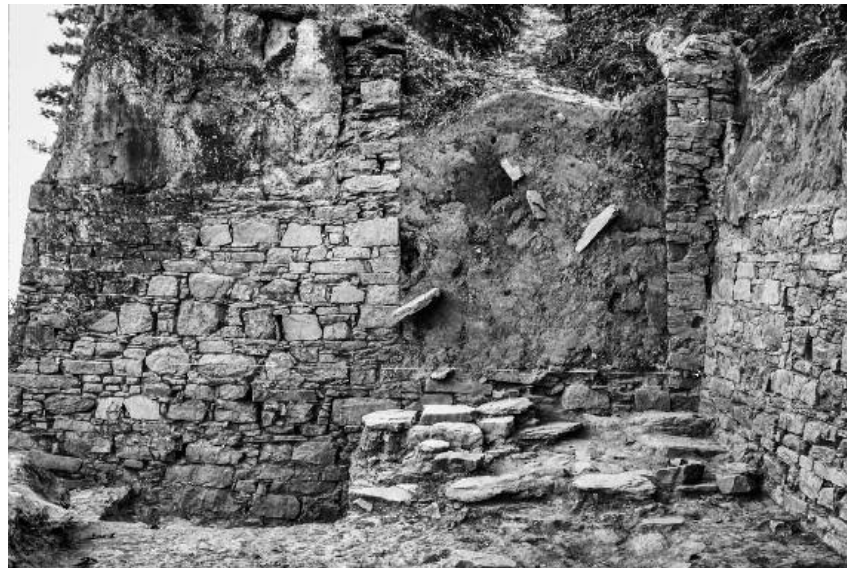
22

Fig.23 Chubjakha Dzong, Paro Dzongkhag, Bhutan. Exposed section of wall 12. View from the northwest.

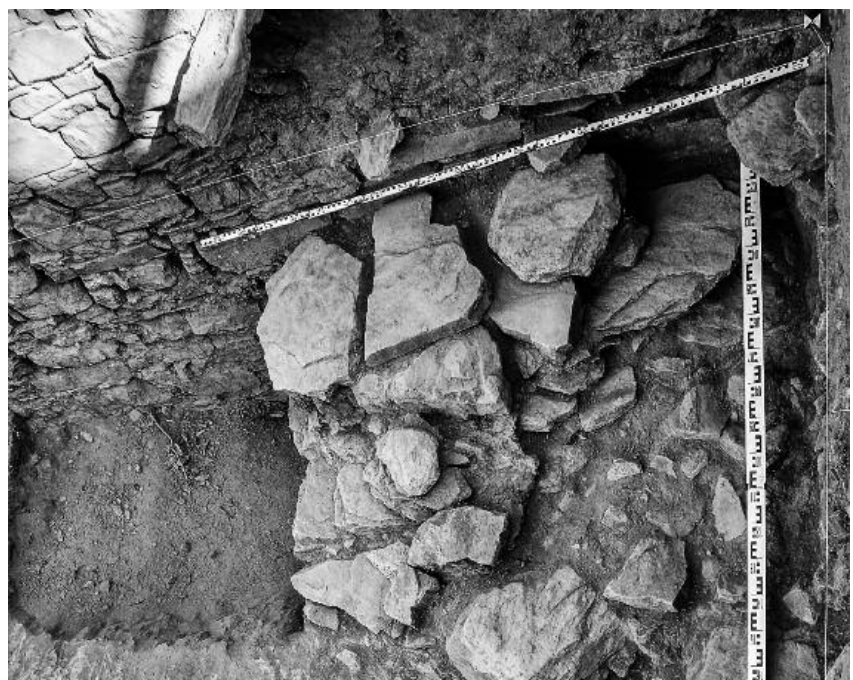
**Fig.25** Chubjakha Dzong, Paro Dzongkhag, Bhutan. Stone-by-stone view of the exposed main entrance. 13.1 Rammed earth wall; 13.2 Stone foundation; 13.3 western gate frame; 13.4 eastern gate frame; 33.5 Staircase to the main entrance; 33.7 Door opening filled with mud debris. Illustration: Sumjay Tshering.
