**The Obtsho Dzong Ruin –
Inventory and Documentation of a pre-Zhabdrung Dzong
under Gasas Dzongkhag in Northern Bhutan**

Report of the investigation

Inv. No. 06/01
Obtsho Dzong

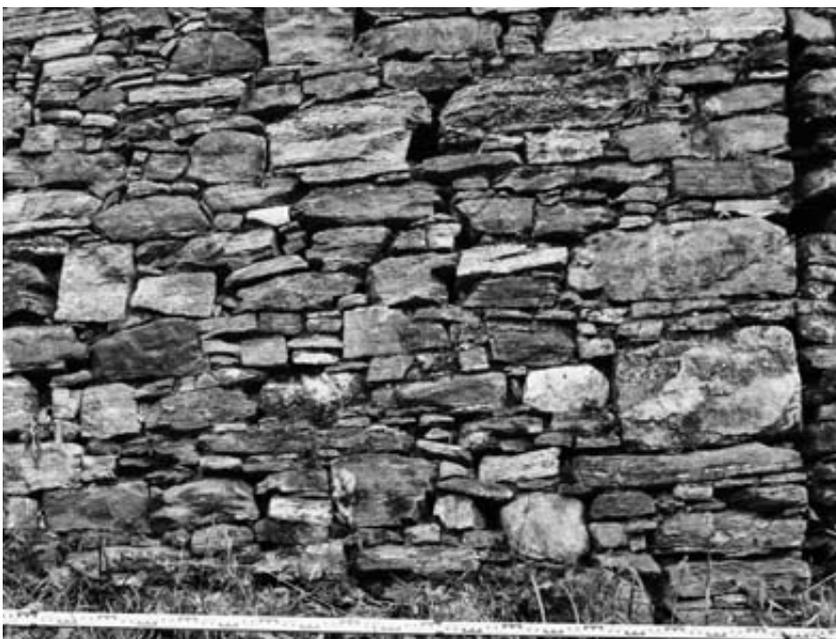
The masonry of all Dzong buildings including the enclosure wall seems to be very consistent and can be described here in a general manner (Fig. 7). It is a double-shelled cavity wall made of roughly processed stones with beige clay used as a binding agent.

Fig. 7 Obtsho Dzong ruin. Detail of a typical wall section. Outside of the enclosure pos. 10.4.

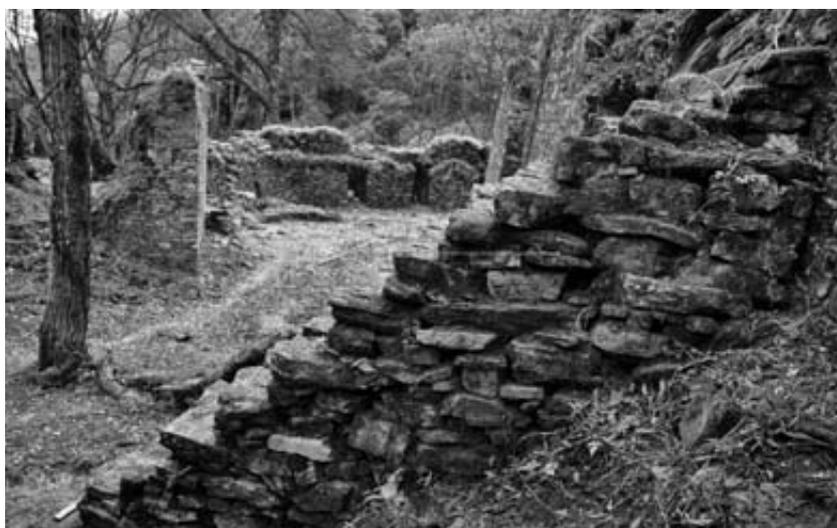
Fig. 8 Obtsho Dzong ruin.
Staircase pos. 1.2 to the Utse.

Stone staircase as today's access to the *Utse*, not the original construction, later addition, connecting directly to the second floor of the *Utse*. Dry masonry, hardly processed rectangular or platy stones of different sizes in irregular layers (Fig. 8). The staircase lies on the same axis to the Position 6.3 (S wall of structure 6) and starts from the collapsed part of the wall pos. 6.3.

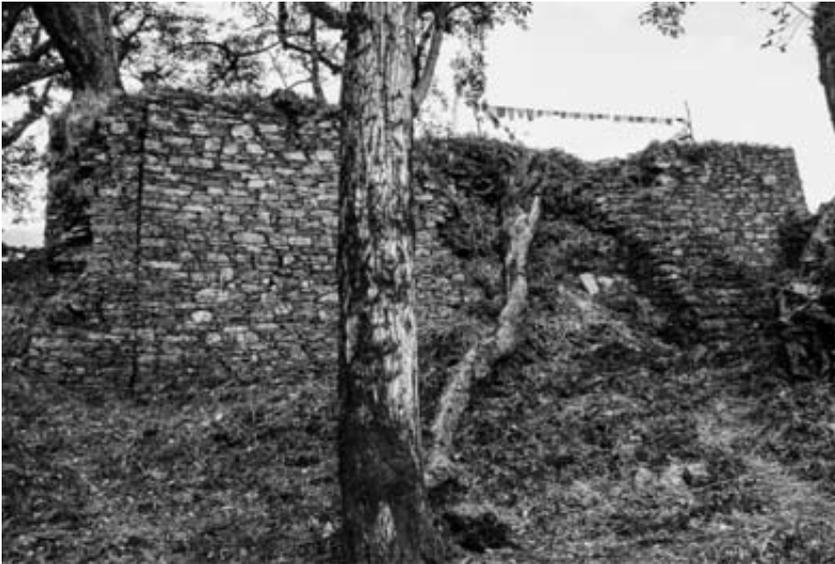
Fig.9 Obtsho Dzong ruin. East face of the wall and staircase pos. 1.1–1.5 of the Utse.

Eastern wall of the *Utse* southern part, continuation of pos. 1.3. Not in connection with the southern *Utse* wall pos. 1.5 (Fig. 9).

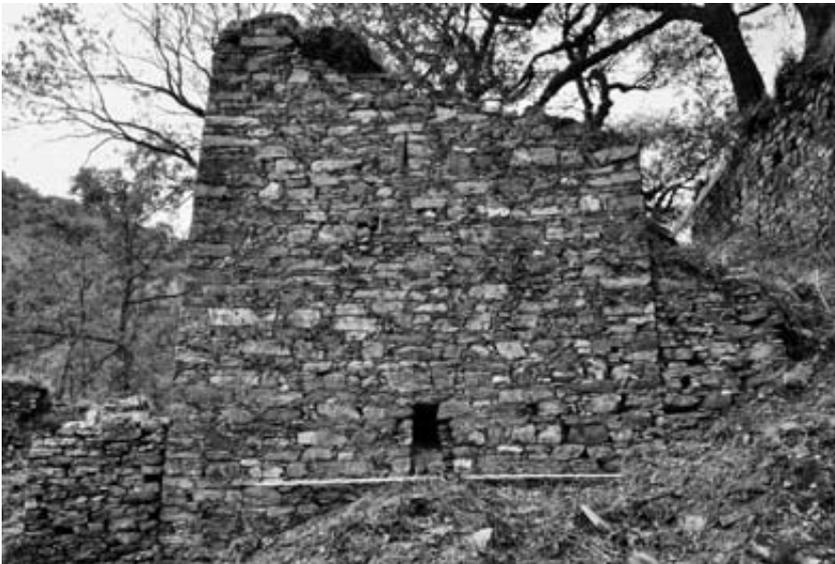
Fig.10 Obtsho Dzong ruin. East face of the wall pos. 2.1 and 2.2 of the building pos. 2

Eastern wall of the building pos. 2 (Fig. 10). There are two openings in the wall: one window, or more likely a drain outlet 30×80 cm on the base of the ground floor level, and one slit 5×40 cm on the first floor level. This wall pos. 2.2 is interlocked with the southern wall pos. 2.3.

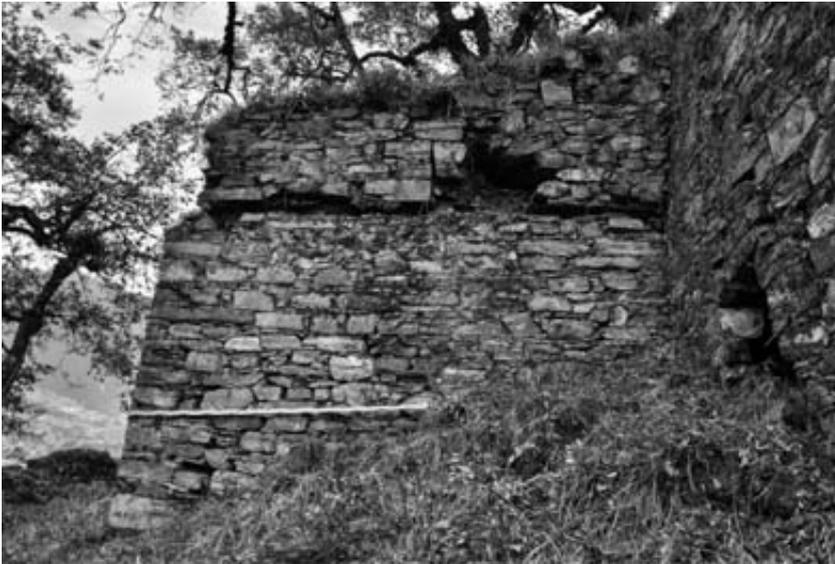
Southern masonry wall of the corridor pos. 4. The wall pos. 4.1 adjoins the wall pos. 2.4. and is interlocked with the western corridor wall 4.2. On the outside, in the middle of the wall pos. 4.1, there is a hollow horizontal band. Probably a wooden beam, which is rotted away now, must have been inserted there (Fig. 11).

Fig. 11 Obtsho Dzong ruin. South face of the wall pos. 4.1 of the corridor pos. 4.

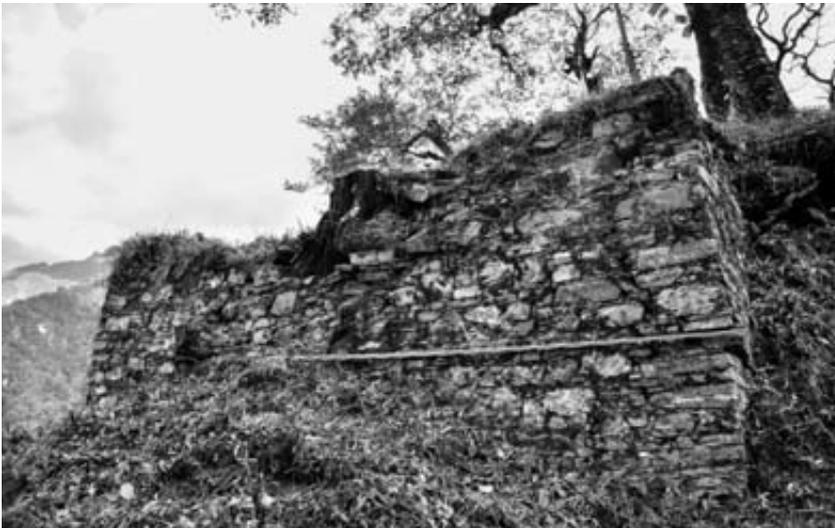
Fig. 12 Obtsho Dzong ruin. West face of the wall pos. 5.2 of the building pos. 5.

Southern masonry wall of building pos. 5 (Fig. 12). A huge tree grew on top of the wall, causing damage to the structure. But it still seems not to be interlocked with the corridor wall pos. 4.2.

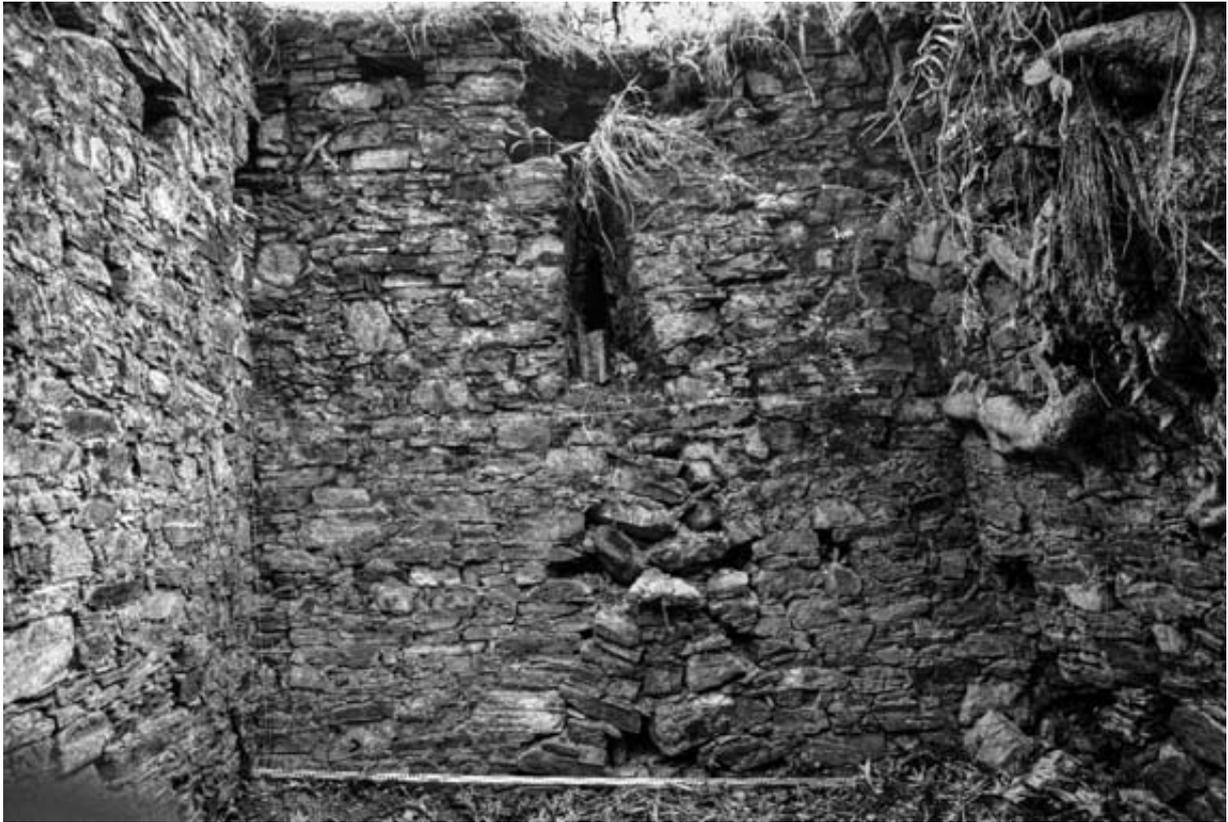
Fig. 13 Obtsho Dzong ruin. East face of the wall pos. 6.2 in the interior of the building pos. 6.

This building is attached to the eastern side of *Utse* pos. 1. It is two stories high. Due to the wall thickness of only 90 cm this building cannot have been much higher and therefore should not be considered as a watch tower but rather as a residence. The interior measures approx. 4.5×9 m (Fig. 13).

Eastern masonry wall of building pos. 6. On the first floor level, there is a shooting slit for defence purposes. The masonry corner joint between the walls of position 6.2 and position 6.3 is quite unique and is overlapped in layers, like a corner joint in a rammed earth construction.

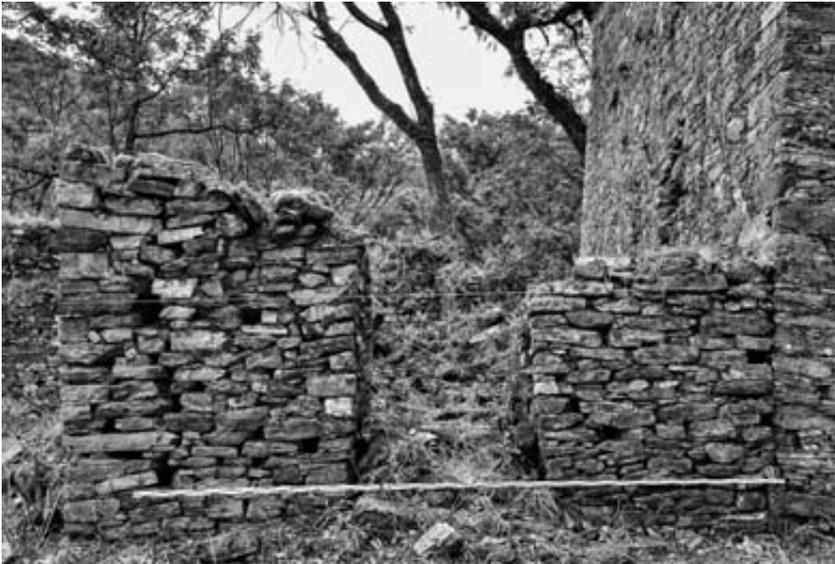
Fig. 14 Obtsho Dzong ruin. East face of the wall pos. 7.1 with the door of the building pos. 7.

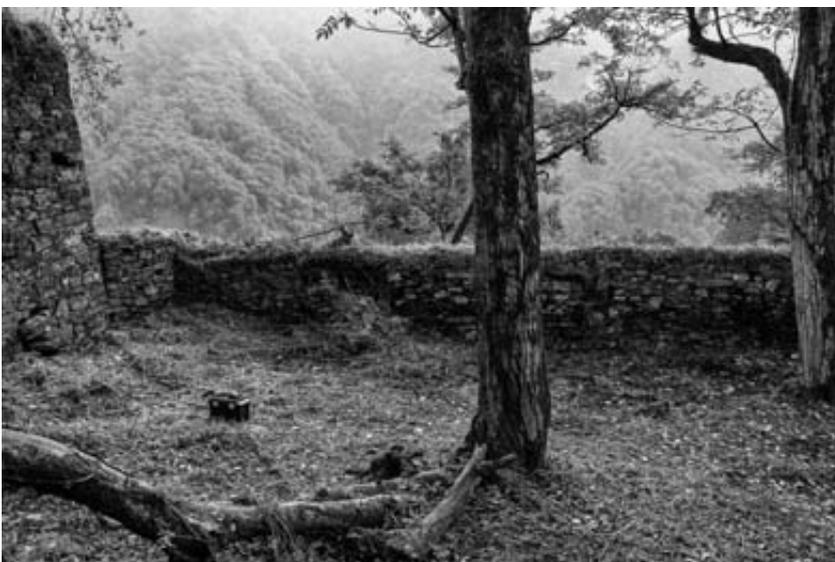
There is an enclosure wall pos. 8 (earlier described as 10.1), with a thickness of 1.3 m, which extends from the eastern entrance tower pos. 9 to the northern building pos. 6 (Fig. 15). It was used for defence purposes – meanwhile it serves as a retaining wall of the courtyard. The wall does not have interconnection to the buildings pos. 6 and 8, but both the ends adjoin the buildings pos. 6 and 9. Although shooting slits like those of the defence wall pos. 10 are missing, different openings did nevertheless exist to-

Fig. 15 Obtsho Dzong ruin. Enclosure wall pos. 8. View from the inside. At the left corner of the building pos. 6.

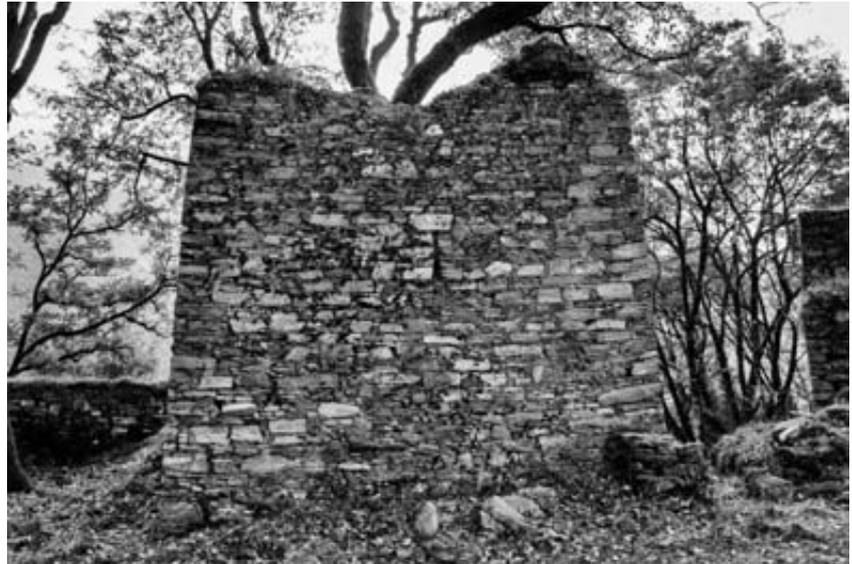
Fig. 16 Obtsho Dzong ruin. West face of the wall pos. 9.1 of the entrance tower pos. 9.

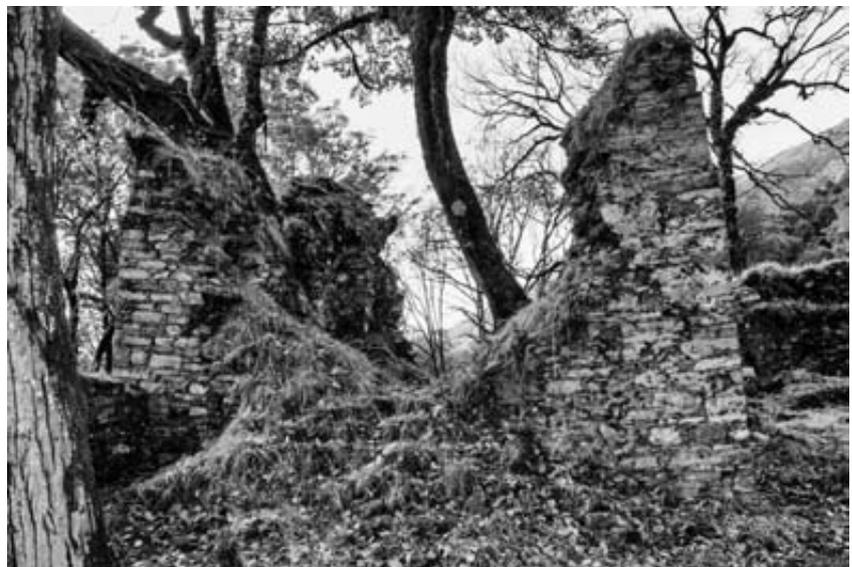
Fig. 17 Obtsho Dzong ruin. North face of the wall pos. 9.2 of the entrance tower pos. 9.

Northern wall of the gate tower pos. 9. The inner gate must have been situated here. Since the wall collapsed in the middle, no remains of a gate were observed (Fig. 17). Further excavations are necessary to clarify this feature.

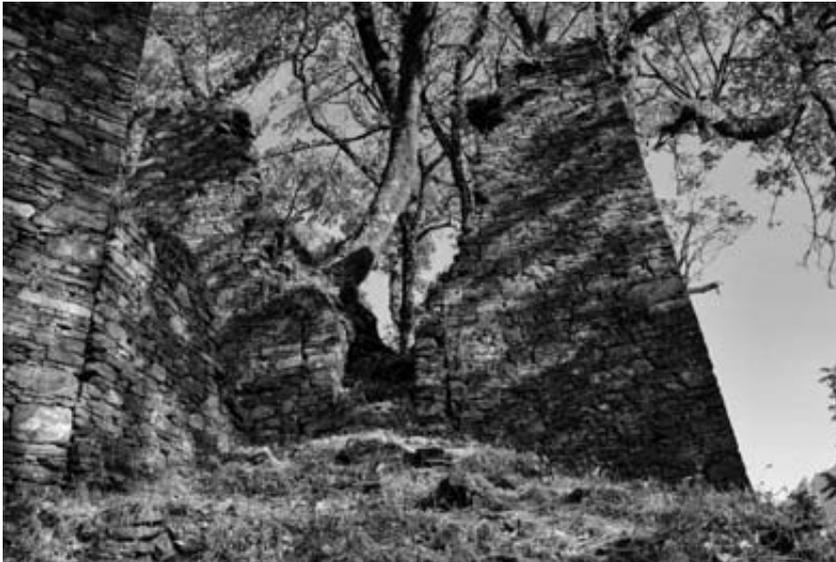
18

Eastern wall of the gate tower pos. 9 (Fig. 19).

Fig. 19 Obtsho Dzong ruin. East face pos. 9.4 of the entrance tower pos. 9 in the foreground on the left side. In the background: enclosure wall pos. 8.

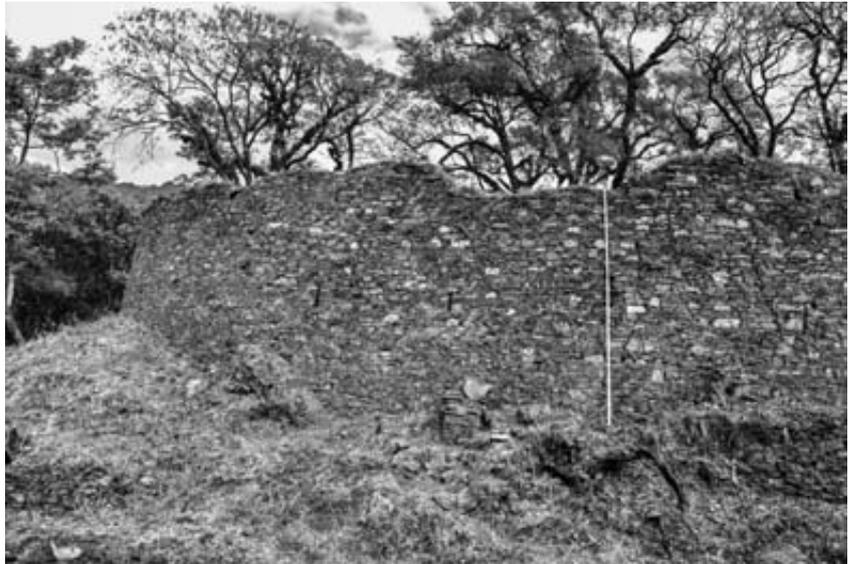
Fig. 20 Obtsho Dzong ruin. Defence wall pos. 10.4 from the outside. At the foot of the defence wall on the right side: retaining wall pos. 11.4, and in the middle Lukhang pos. 11.5.

Southern part of the enclosing defence wall in a semi-circular shape (Fig. 20). It stretches from the gap respectively the wall pos. 10.3 in the east to the courtyard partition wall pos. 10.7 in the northwest. The defence wall pos. 10.4 is two-storied with a parapet walk on the inside at a height of approx. 3 m. The wall's maximum height on the out-

In the middle of the defence wall pos. 10.4, immediately at the foot of the wall, there is a Lukhang pos. 11.5 (Fig. 20, 29). It is attached, but not interlocked, to the outer shell of the enclosure. The Lukhang measures 60×70 cm on the ground plan. The stones of the Kaymaar are coloured red. The top part of the Lukhang has been damaged by falling stones from the defence wall.

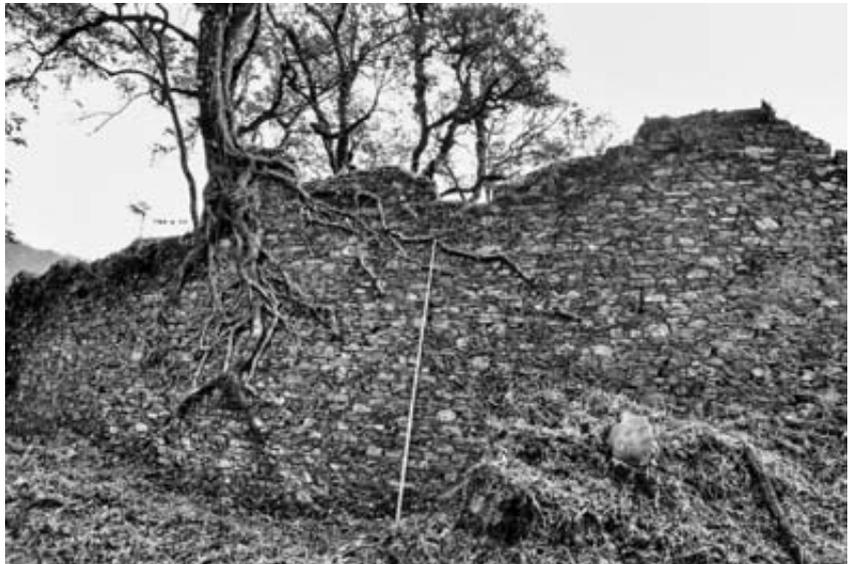
Fig. 21 Obtsho Dzong ruin. Defence wall pos. 10.4 and 10.8 from the outside.

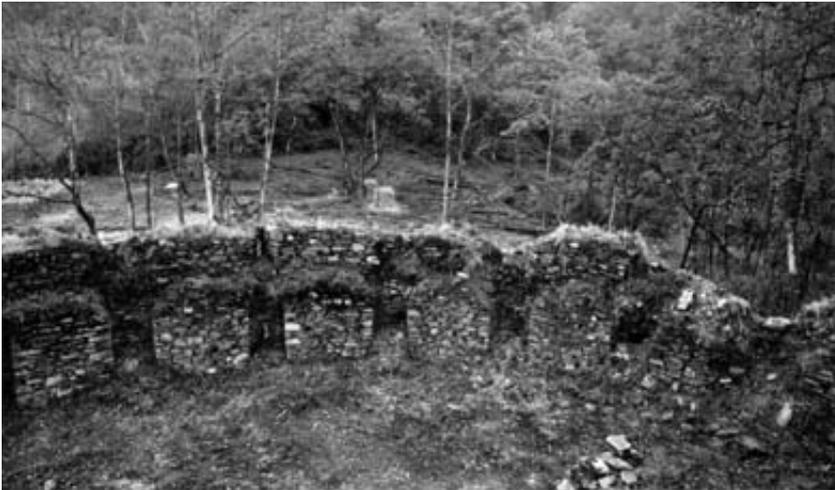
Fig. 22 Obtsho Dzong ruin. Defence wall pos. 10.4 from the inside.

side measures approx. 7 to 8 m. On the interior ground floor level, the wall thickness measures approx. 2 m, and twelve shooting slits can be observed: a broad opening of a 90 cm width leads to a narrow slit which is only 10 cm wide. The lintels of the slits are made of one flat stone. One shooting slit opening has been filled with masonry (pos. 10.6). The wall thickness of the parapet measures approx. 1 m. Its upper part is largely destroyed, but a few shooting slits in the vertical axis of the ground floor slits are still visible.

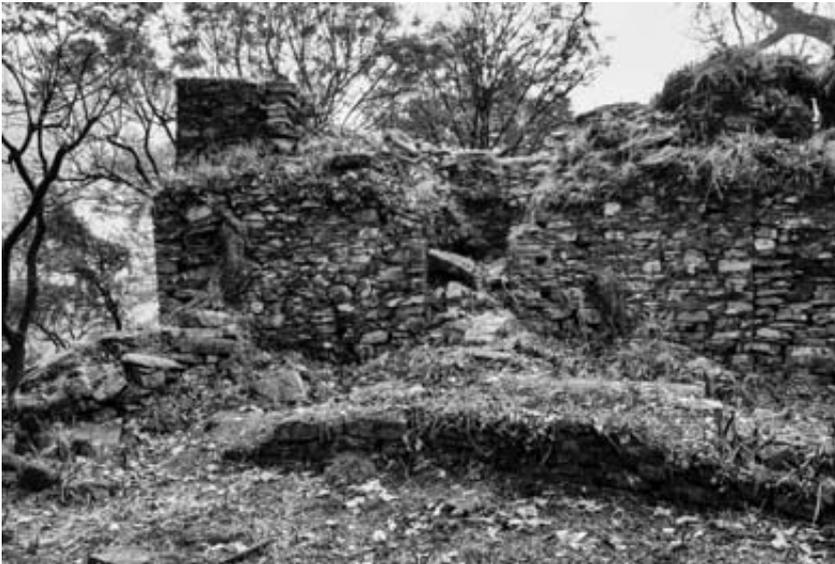
Fig. 23 Obtsho Dzong ruin. Defence wall pos. 10.4 from the inside. Detail of the first two shooting slits. The second one has been bricked up (pos. 10.6). In the foreground: wall pos. 10.5.

Second shooting slit from the east. At an unknown date this opening in the defence wall was filled with stone masonry which is comparatively poor (Fig. 23). On the outside we can see a vertical crack running down the wall at this point. Therefore we assume that the opening might have been blocked to increase the strength of the defence wall pos. 10.4 (see also Position 11.4).

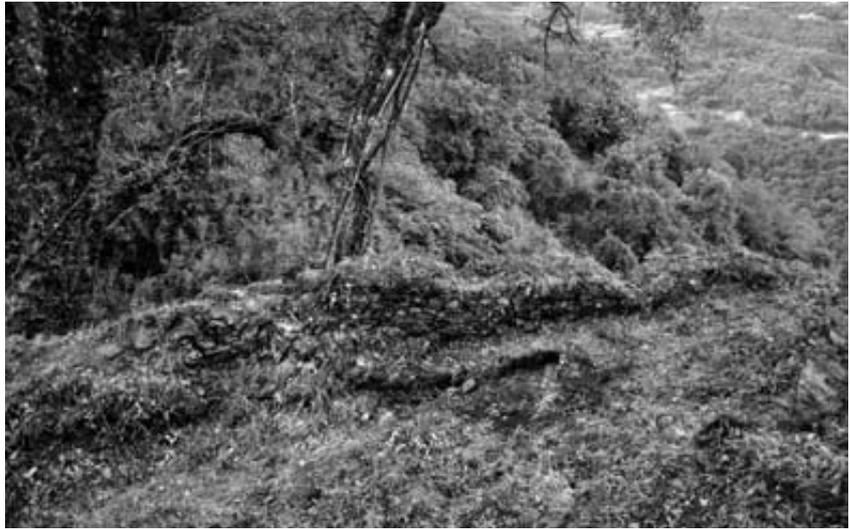
Fig. 24 Obtsho Dzong ruin. Defence wall pos. 10.8. At the right corner pos. 5.1.

The continuation of the defence wall pos. 10.4 starts from the partition wall pos. 10.7 and ends in the north by adjoining the building pos. 5. It is in a slightly curved shape (Fig. 24). On the outside of the enclosure, no change of character of the wall can be observed, but the section to the north is lower than the section prior to the partition pos. 10.7. On the interior, we can see that the level of the parapet walk is about 2 m lower. The thickness of the parapet wall measures 70 cm. In this northern section of the enclosure there are three shooting slits which are only visible from the outside since the backside courtyard is filled with debris. The outlet of the drainage can also be found on the outside and at the base of the wall towards the north.

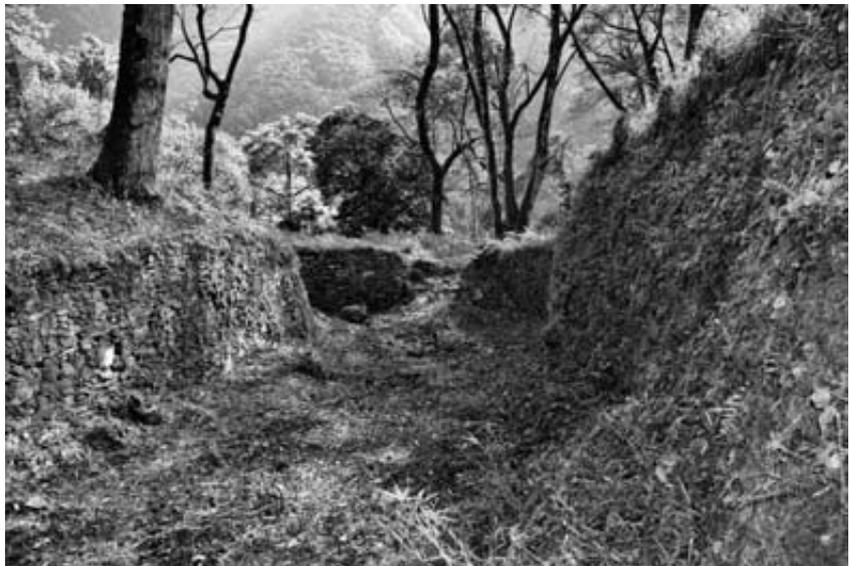
Fig. 25 Obtsho Dzong ruin. Ditch/trench pos. 11 with the inner and outer escarpment walls pos. 11.10 resp. pos. 11.11. View of the bridge pos. 11.1 and 11.2.

There is a ditch pos. 11 which separates the Dzong from the terrace. It starts from the east and leads in a quarter-circle shape around the fortress to the north. The ditch is up to 7 m wide. There are slightly tapering inner and outer escarpment walls (pos. 10.10

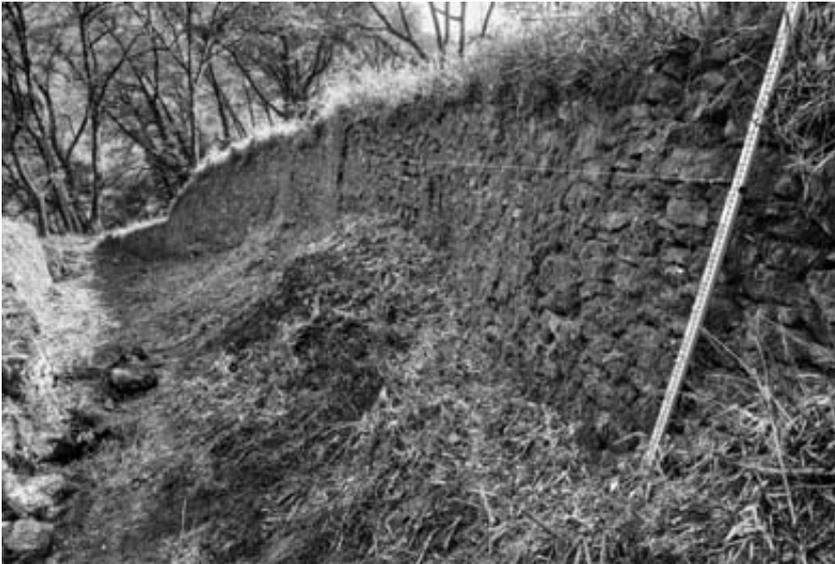
Fig. 26 Obtsho Dzong ruin. Ditch/trench pos. 11 with the outer escarpment wall pos. 11.11. View to the east.

resp. 10.11) with a maximum height of 3 m. The masonry is a dry wall without binding agents where unprocessed stones of different sizes were used randomly without building any layers. Vegetation growing through the gaps covers most parts of the masonry shell. A bridge pos. 11.1 over the ditch is the only access to the Dzong.

Analogous to pos. 11.10, the outer escarpment wall pos. 11.11 also serves as a revetment (Fig. 26). It runs from the bridge pos. 11.2 to the curve where it was covered by soil (pos. 11.9) and continuously to the north. The first section of the wall pos. 11.11 has a length of 41 m, while the second one is 18 m long. The stones used are generally smaller than those of the inner escarpment wall pos. 11.10. In addition, natural rocks in situ were included in the wall. Due to the swelling of some parts of the outer escarpment, it may well collapse one day.

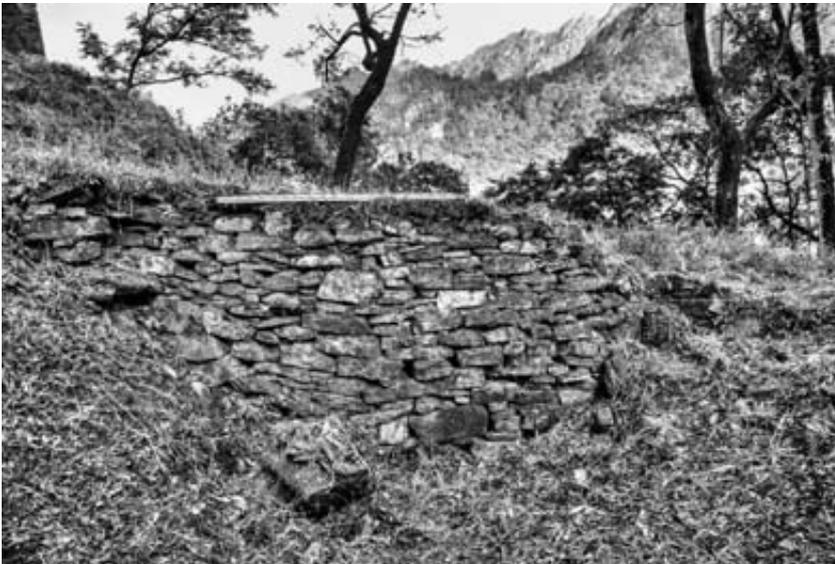
Fig. 27 Obtsho Dzong ruin. Bridge pos. 11.1. West face of the wall.

The ditch pos. 11 which separates the Dzong towards the south is crossed by a bridge pos. 11.1 which is 2.8 m wide. It represents the only access path to the fortress and can also be described as a ramp, since there is no passage underneath the structure from the western part of the ditch to the eastern part (Fig. 27–28). The bridge is built of dry stone masonry. Plate-like flat stones of different sizes were used in more or less horizontal layers. The surface of the bridge cannot be seen as it is covered with topsoil.

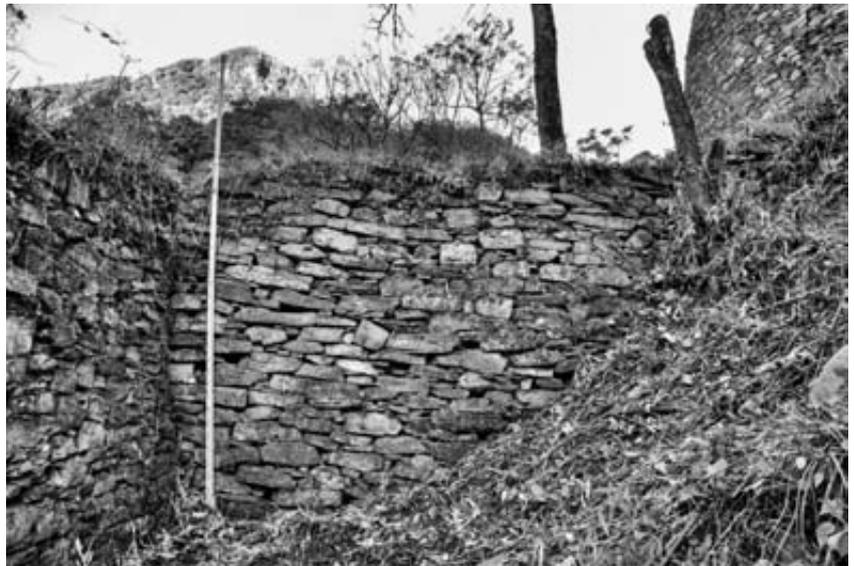
Near the junction to the outer escarpment wall, the western masonry shell of the bridge seems to be collapsed, since there is a 2 m wide gap. We found several stones that look like steps. Their size is much bigger than the size of other stones used for the bridge. Probably there was a small staircase as an entrance to the trench. Further excavations are necessary to clarify this feature.

Fig. 28 Obtsho Dzong ruin. Bridge pos. 11.1. East face of the wall.

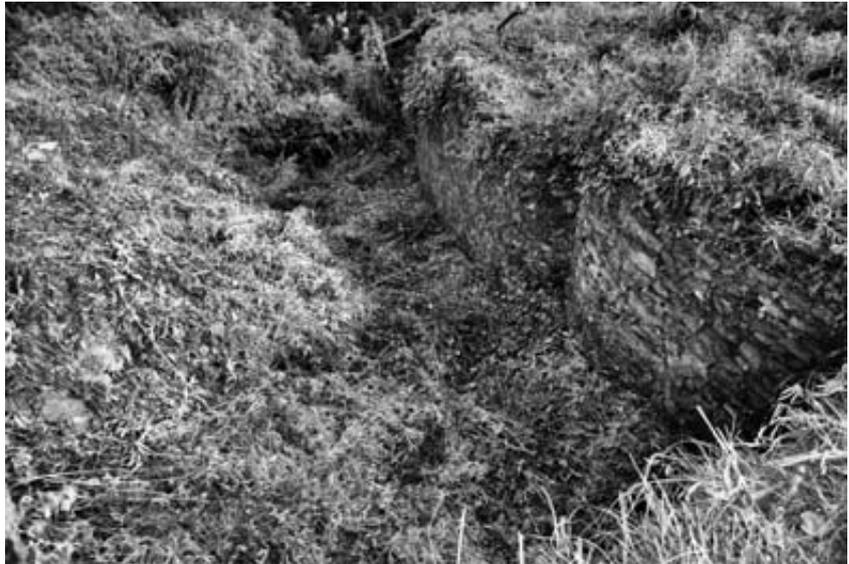
Fig. 30 Obtsho Dzong ruin. Outer escarpment wall of the ditch/trench pos. 11.12. View to the east.

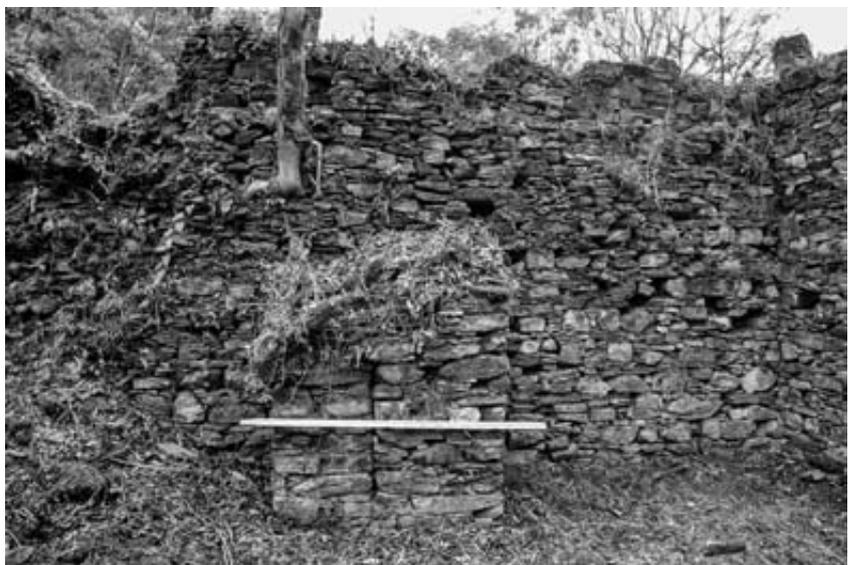
Fig. 31 Obtsho Dzong ruin. Ground floor of the building pos. 12 with massive masonry serving as a stand for oven or herd on the first floor.

thickness of 75 cm, features the holes of the beams which indicate the upper floor. On the ground floor there was a massive masonry of 1.3×1.6 m footprint (Fig. 31). It seems to be a stand for a traditional oven or herd on the first floor. Therefore we assume that the ground floor was used as a granary or store room, while the upper floor was used as a kitchen and residence. There are also the holes of wooden joists which may come from a traditional kitchen shelf with a length of approximately 3 m. There was a window measuring 50 (to?) $\times 90$ cm on the upper floor of the partition wall towards the northern building pos. 13.

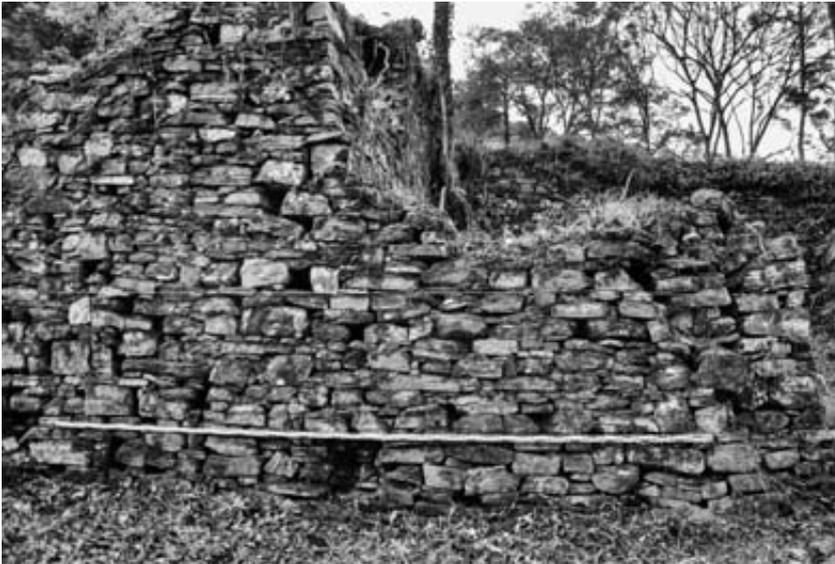
The southern building pos. 12 measures 7.5 (to?) × 5 m on the inside. It is accessed via a curve shaped platform in front of the door. Towards the north there must have been a staircase of approximately 1 m height, but it is collapsed nowadays. The building pos. 12 has two floors. Against the higher-lying terrace to the west, the ground floor is dug into the ground. The partition wall to the building pos. 13 in the north, which has a

Fig. 32 Obtsho Dzong ruin. East face of the wall of building pos. 12 and pos. 13. View to the west.

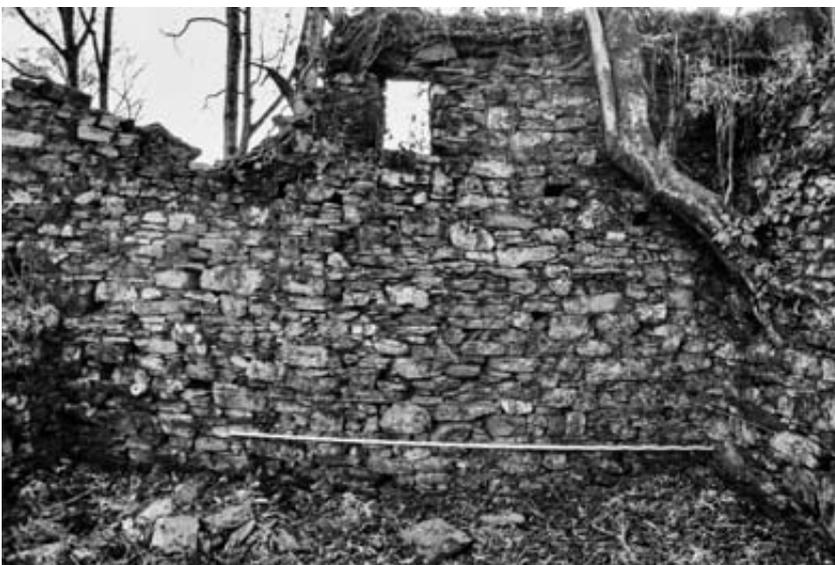
Fig. 33 Obtsho Dzong ruin. Interior of building pos. 13. View of the partition wall between the buildings pos. 12 and pos. 13.

The building pos. 13 measures 6 (to?) $\times 5$ m on the inside. There is only one floor which is dug into the ground, similar to building pos. 12. The partition wall at the building pos. 12 in the south features five beam holes of a pent roof construction which was inclined to the east. Above the roof, the aforementioned window measures 50×90 cm (Fig. 33). As a suggestion, we interpret the building as a barn or a stable for horses or other domestic animals.

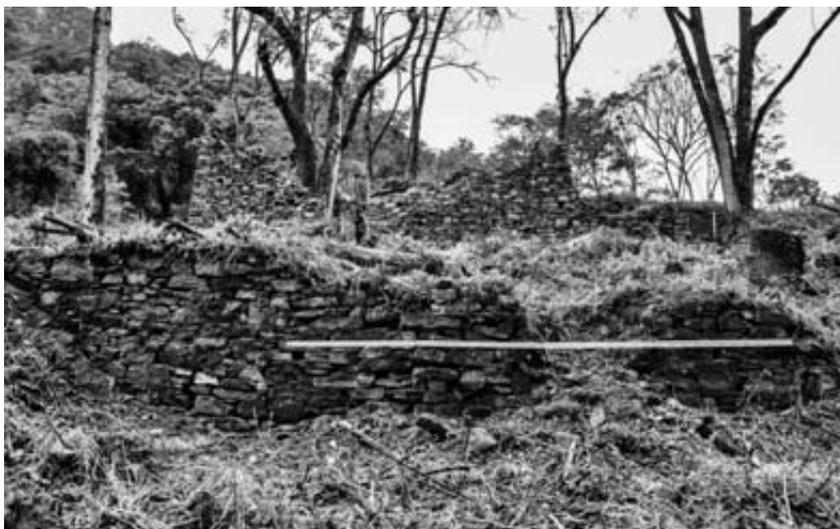
Fig. 34 Obtsho Dzong ruin. East face of the wall of building pos. 14. View to the west.

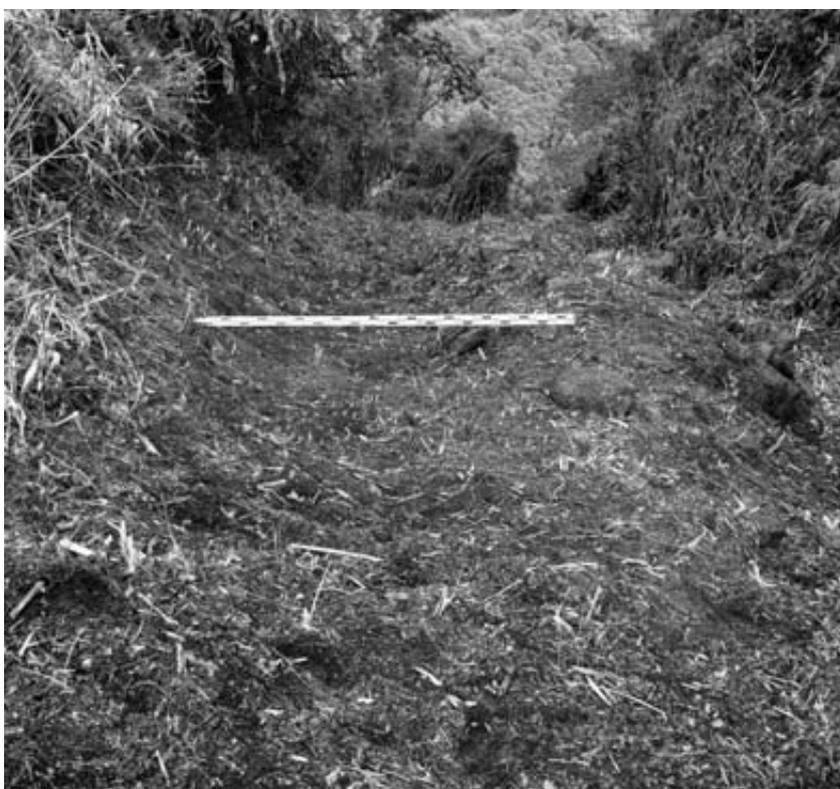
Fig. 35 Obtsho Dzong ruin. Original access path to the Obtsho terrace and the Dzong. View to the north.

At the eastern edge of the terrace, about 10 m before reaching the ditch, a path pos. 15 was rediscovered, which leads down the hillside in a Z-shaped line. The path was very difficult to follow due to the fact that it is covered with dense bamboo jungle. Only the first few meters were cleaned by the participants (Fig. 35). The path is about 2 m wide. In the upper section there is debris of a retaining wall on the valley side. There is no doubt that the path pos. 15 is to be regarded as the original access to the Obtsho Dzong which led to the Punakha-Gasa footpath.

On the eastern edge of the terrace there is an outer bailey complex belonging to the Obtsho Dzong which measures approx. 40 × 20 m. It lies at an altitude of approx. 2,528 m.a.s.l. Three buildings resp. rooms pos. 12–14 were documented, but it must be assumed that there are many more structures hidden in the ground (Fig. 31–34). Furthermore, from here the rediscovered access path pos. 15, which in former times connected the Punakha-Gasa footpath with the Dzong, branches off in the northeastern direction and runs down the hillside in a zig-zag line (Fig. 35).
